BEFORE THE PUBLIC UTILITIES COMMISSION OF NEVADA

Application of Great Basin Water Co., Pahrump, Spring Creek, Cold Springs, Pahrump, and Spanish Springs Divisions for Approval of its 2024 Integrated Resource Plan and to designate certain system improvement projects as eligible projects for which a system improvement rate may be established, and for relief properly related thereto.

VOLUME 8 OF 18

**Inspection Report for
Great Basin Water Company
Reno, NV**

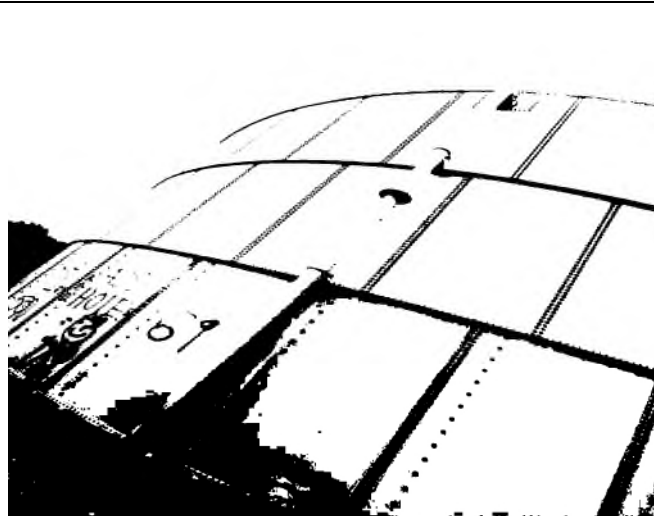
Summary: The overflow was found in good condition with minor staining noted and is directly connected to the storm drain.

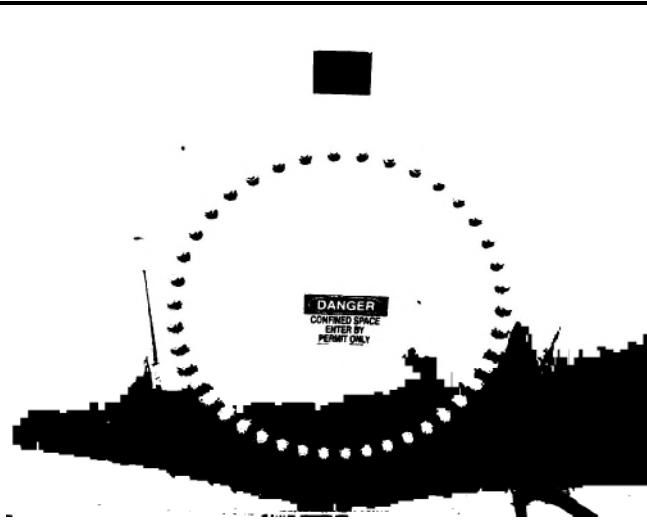
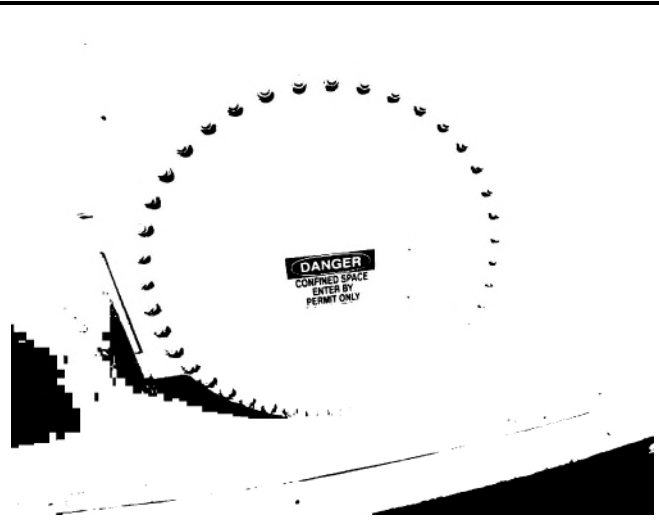
Summary: The manways were found in good condition with minor chalking and 0.01% uniform surface corrosion noted.

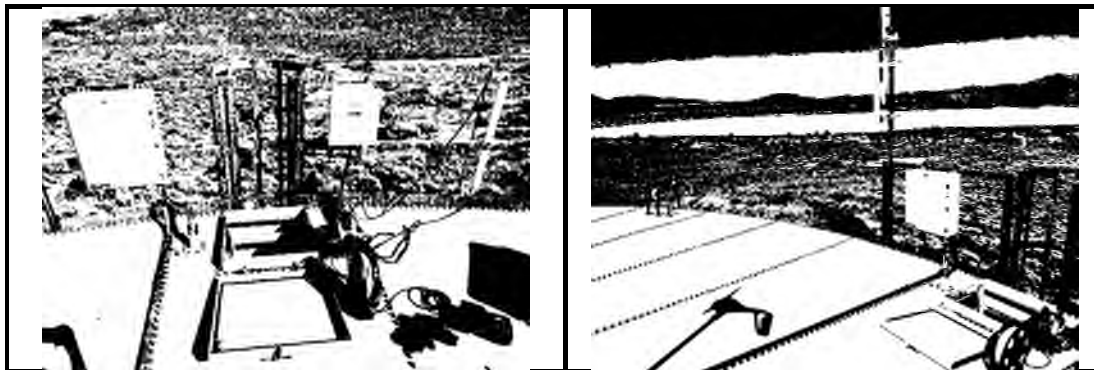
Roof Railing - Roof railing is compliant however it does not extend very far to either side, providing very limited protection. Additionally, there is no gate at the roof access.

It is recommended to install railing in each direction (4' to the right and 15-20' to the left) to include the LLI enclosed pulley system and add a self-closing gate between the two sections of roof railing.

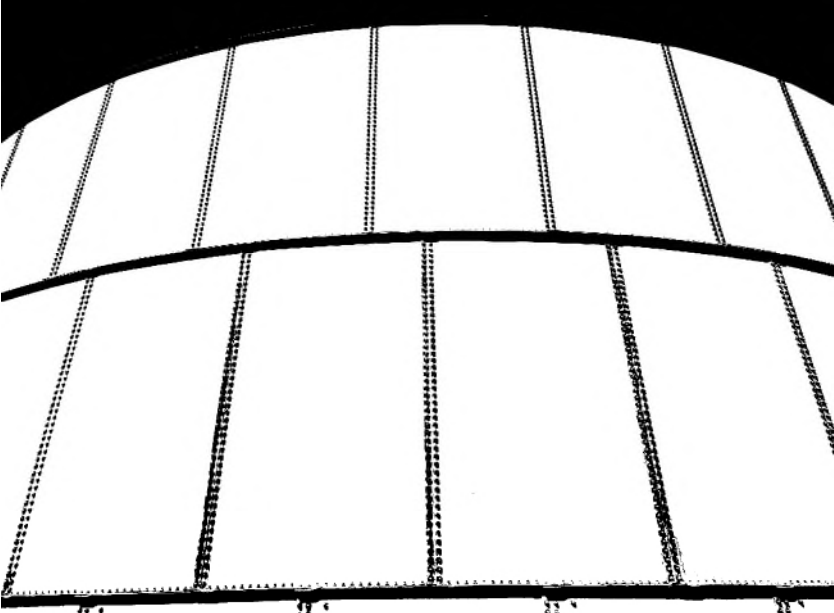
| Exterior | Typical shell condition with discoloration and mineral deposits from past leaks. |

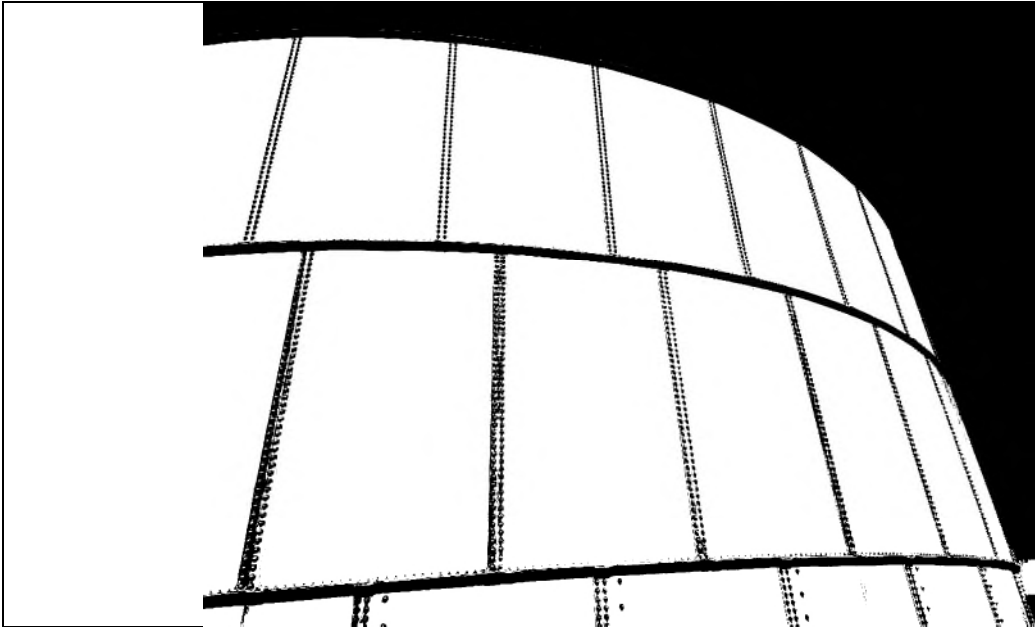
Exterior

Typical shell condition with discoloration and mineral deposits from past leaks.

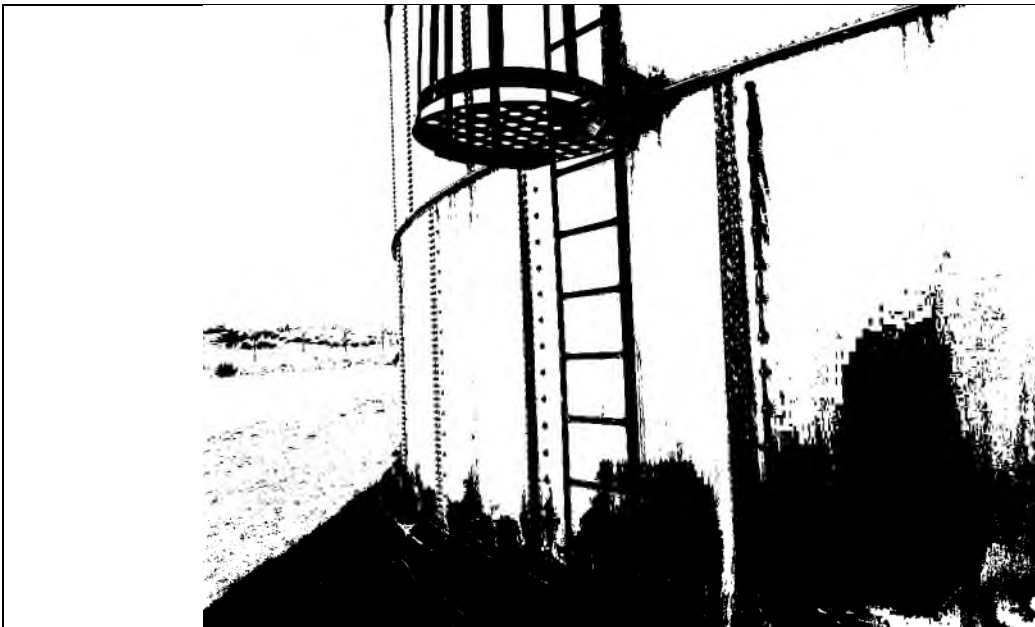
Exterior

Access ladder with drop down ladder gate, lock, and safety cage. NO fall arrest system on the exterior ladder.

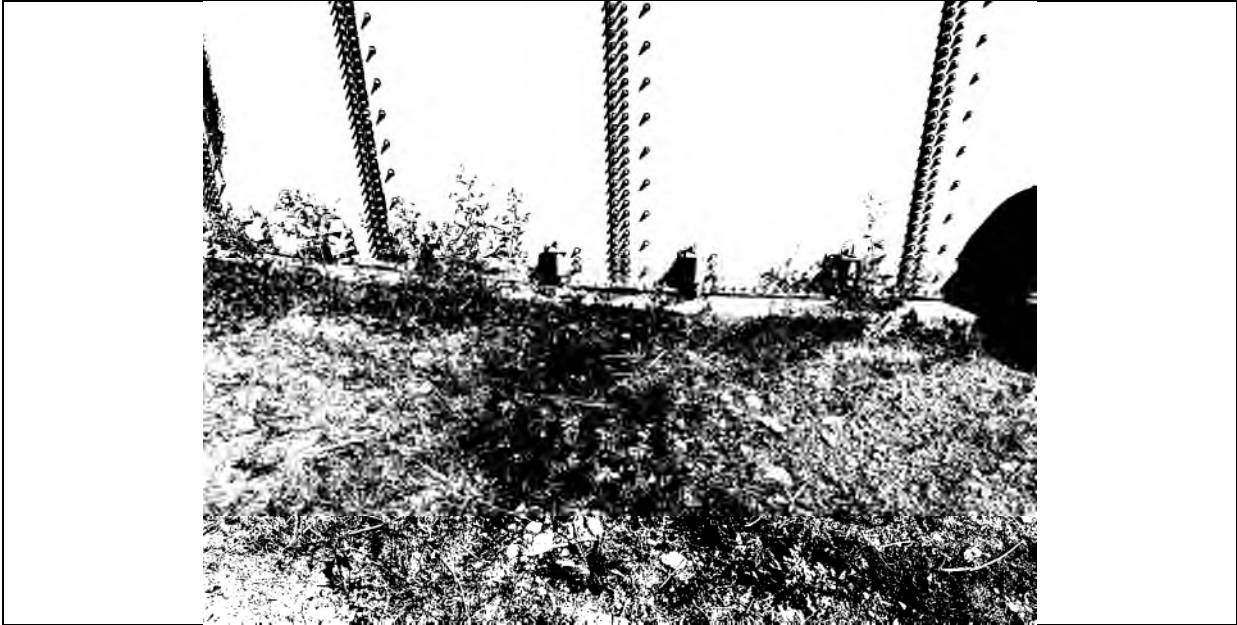
Exterior

Active leak at the floor chime

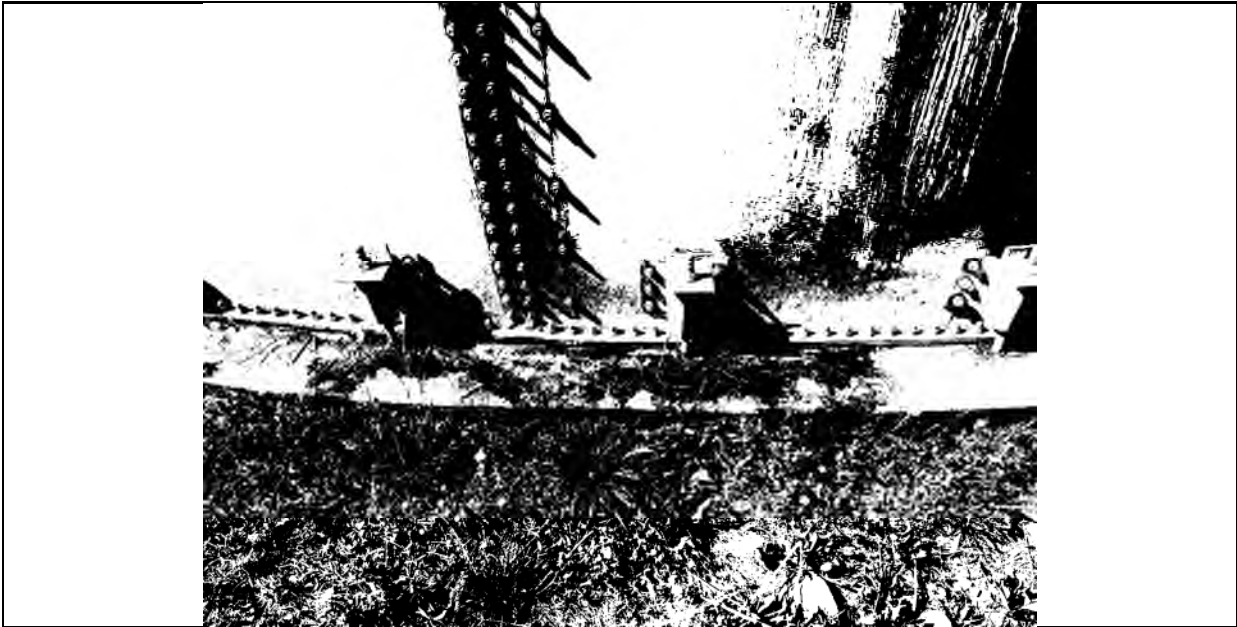
Exterior

Active leak at the floor chime

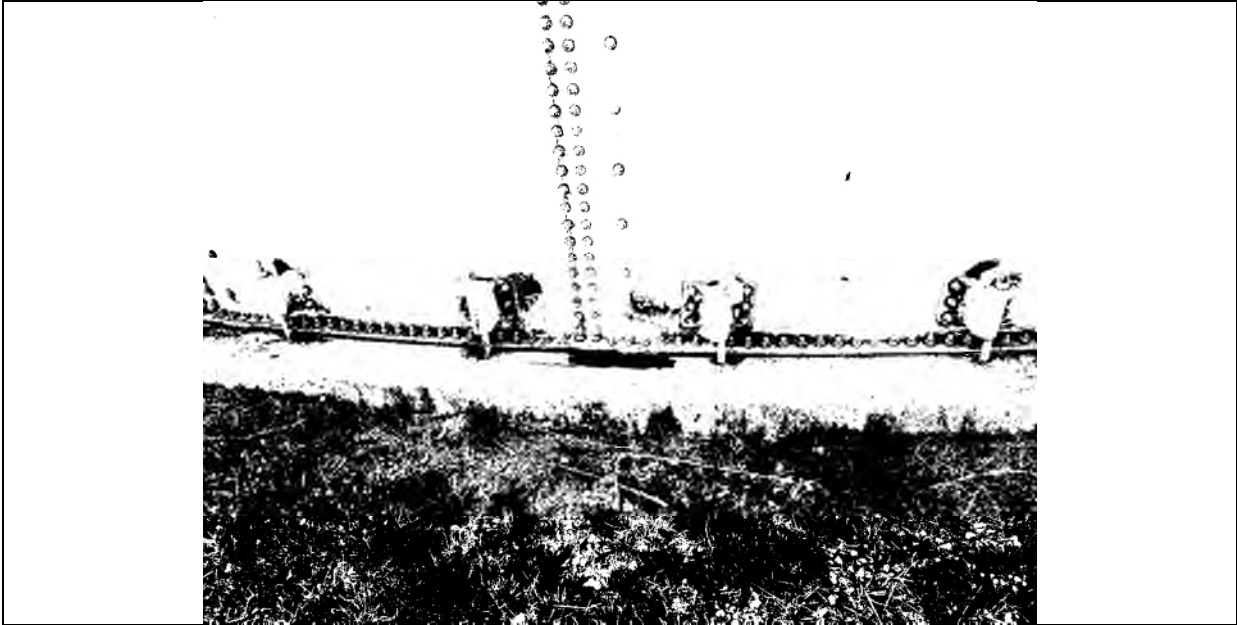
| Exterior | Active leak at the floor chime |

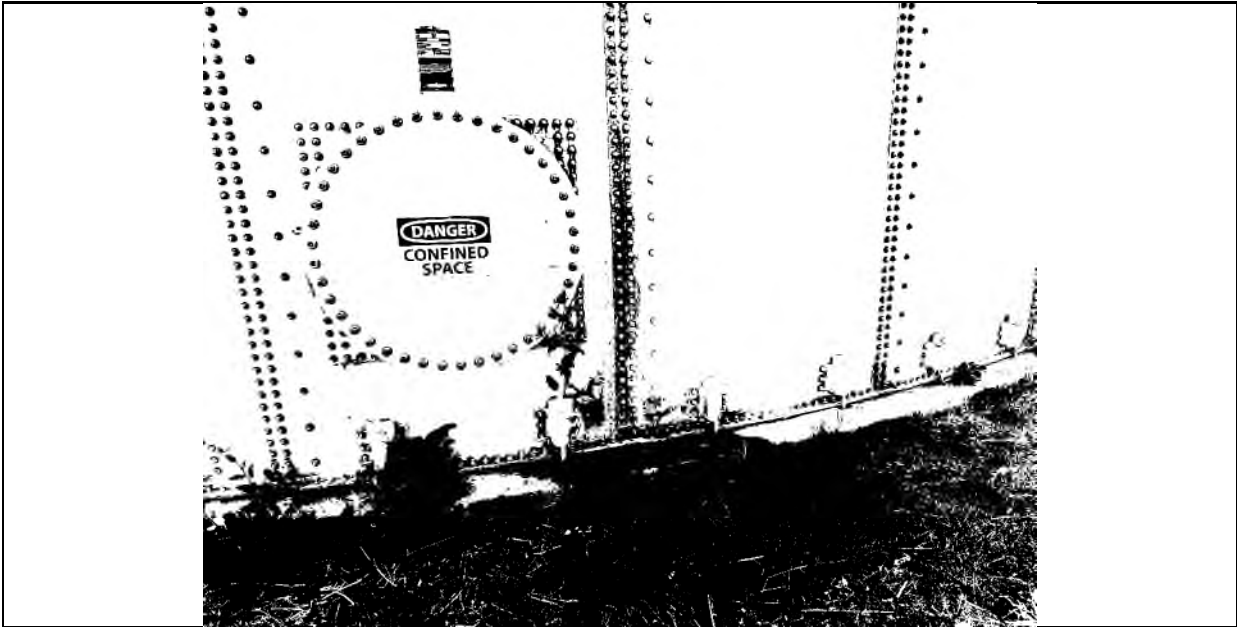
| Exterior | Active leak at the 8' chime |

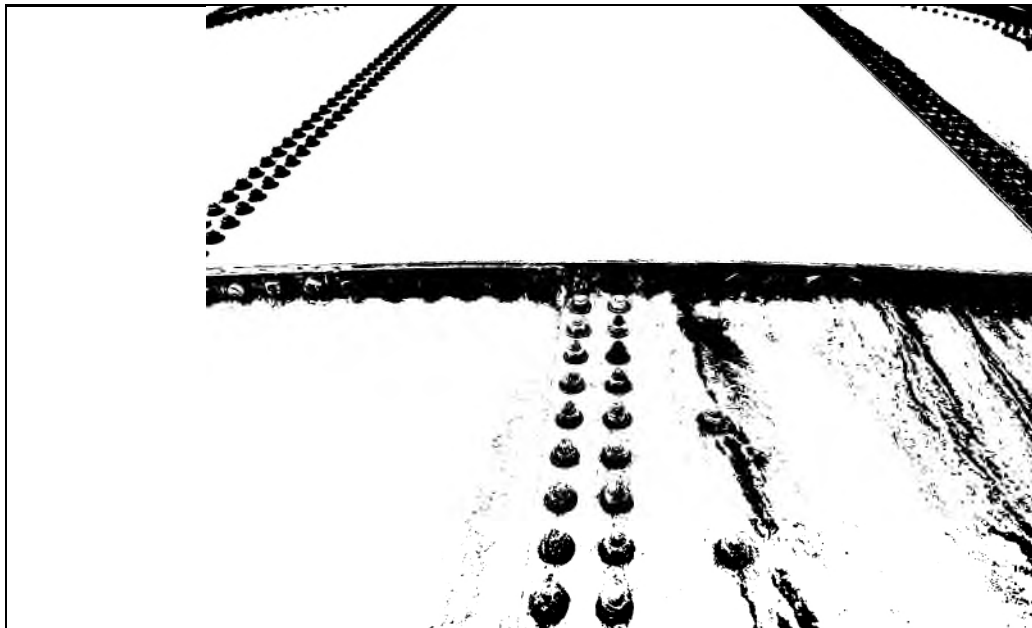
Exterior

Past area where a leak was active, resulting in a heavy buildup of mineral deposits on the tank and hardware

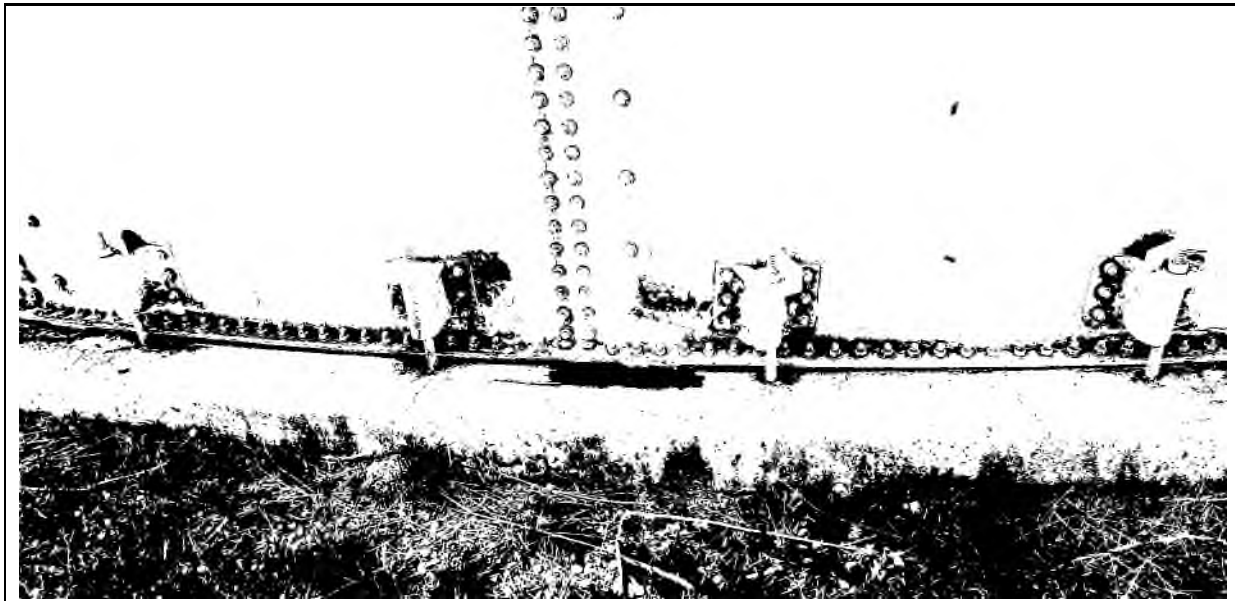
Exterior

Corrosion cells on the center column

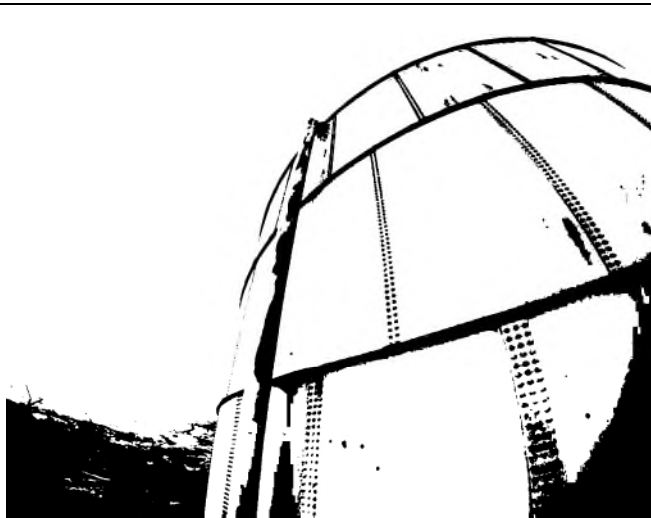
Summary: The overflow was found in good condition with minor de-lamination, oxidation, chalking, staining and 0.01% uniform surface corrosion noted.

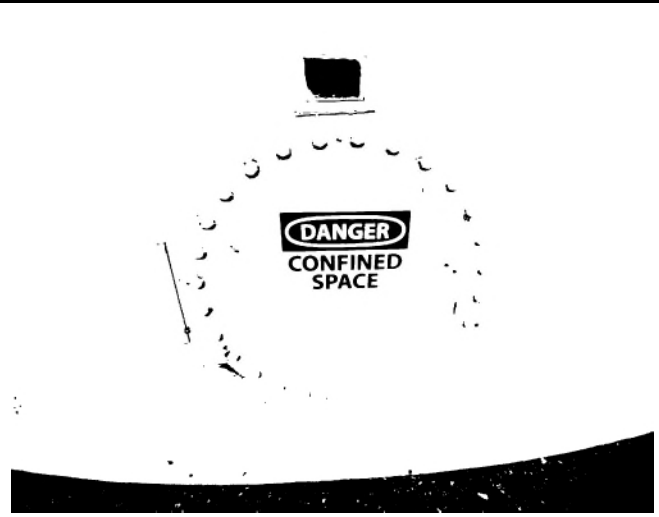
Summary: The manways were found secure and in good condition with moderate sags & runs in the coating and chalking noted.
