BEFORE THE PUBLIC UTILITIES COMMISSION OF NEVADA

Application of Great Basin Water Co., Pahrump, Spring Creek, Cold Springs, Pahrump, and Spanish Springs Divisions for Approval of its 2024 Integrated Resource Plan and to designate certain system improvement projects as eligible projects for which a system improvement rate may be established, and for relief properly related thereto.

VOLUME 8 OF 18

**Inspection Report for
Great Basin Water Company
Reno, NV**

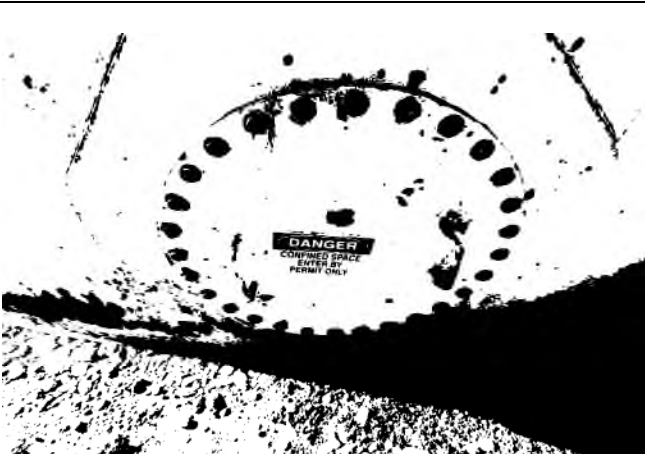
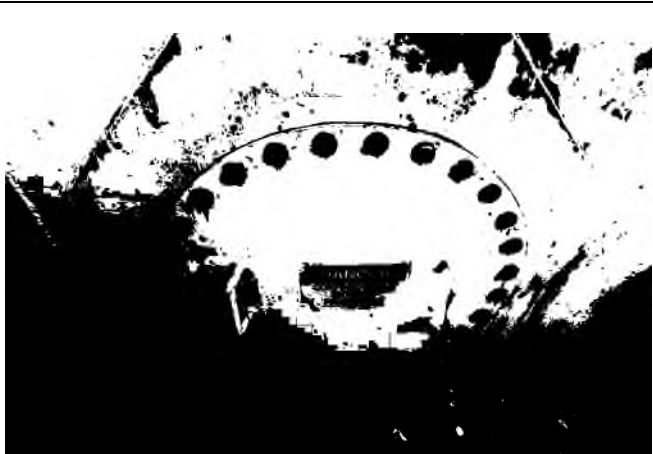
Manway Condition

Summary: The manways were found secure and in good condition with minor de-lamination, sags & runs in the coating and 0.1% uniform surface corrosion noted.

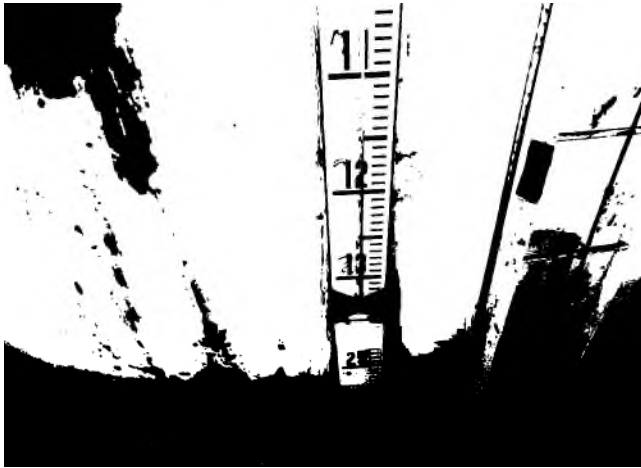
Pulley for water level indicator

Marker Condition: Good/Fair
 Attached & Accurate? Y N
 Marker Board Condition: Good/Fair
 Is the level reading visible? Y N
 Pulley Condition: Poor
 Attached Properly? Y N

Cable Condition: Poor
 Attached Properly? Y N
 Hardware Condition: Good
 Corrosion Present? Y N

Summary: The water level indicator was found in poor condition and not connected to the pulley.

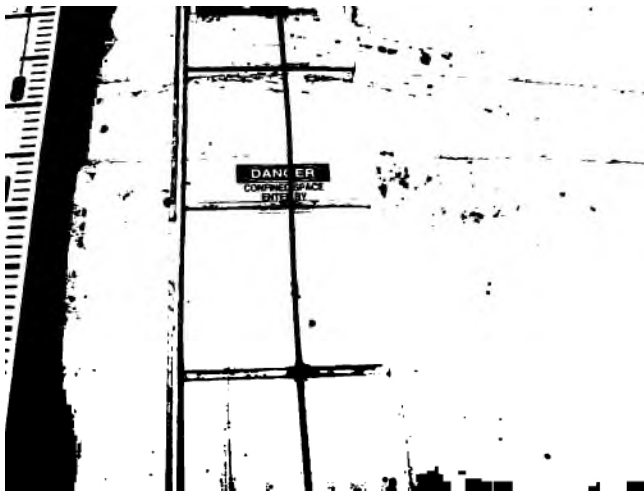
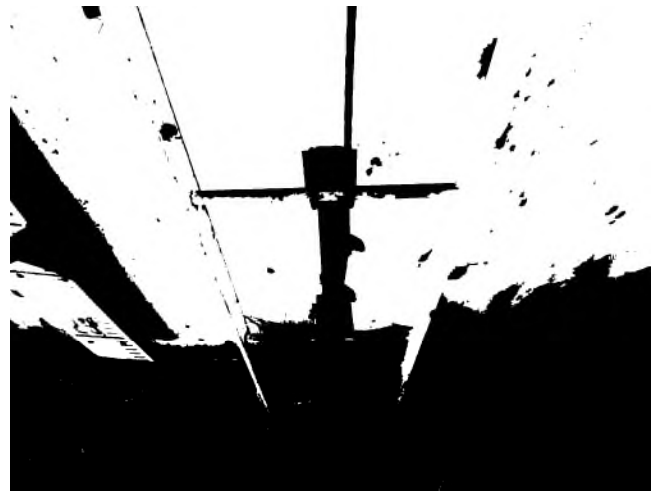
Ladder and safety cable

Summary: The ladder was found secure, OSHA approved and in good condition with moderate de-lamination noted.

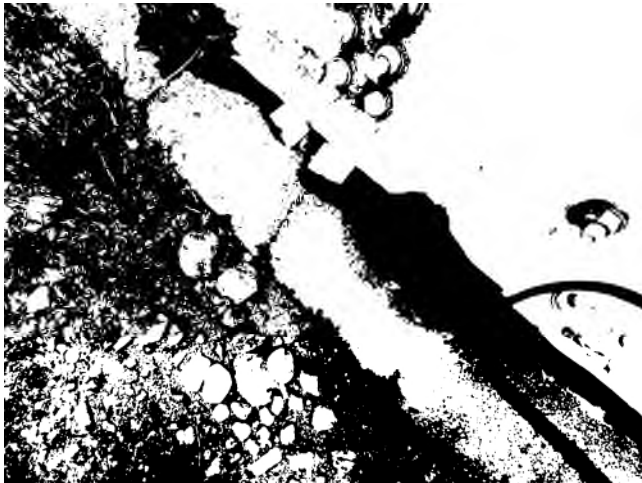
Summary: The foundation was found in good condition with minor moss growth and hairline cracking noted.

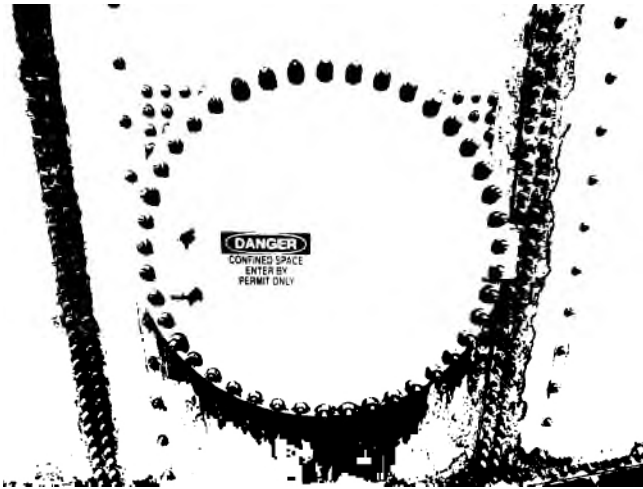
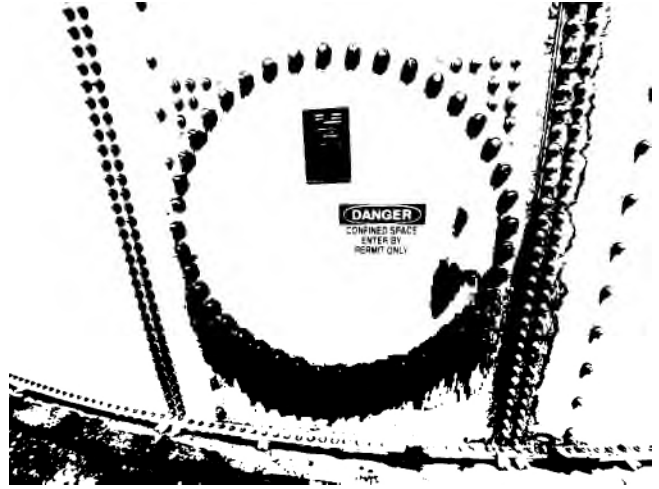
Summary: The manways were found secure and in good condition.

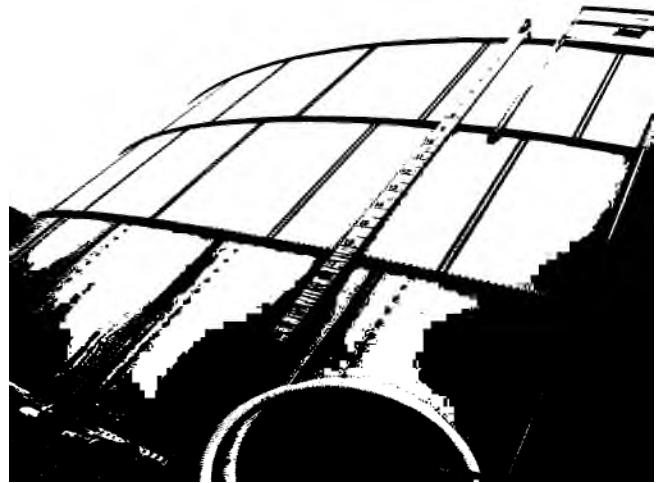
Summary: The water level indicator was found in good condition.

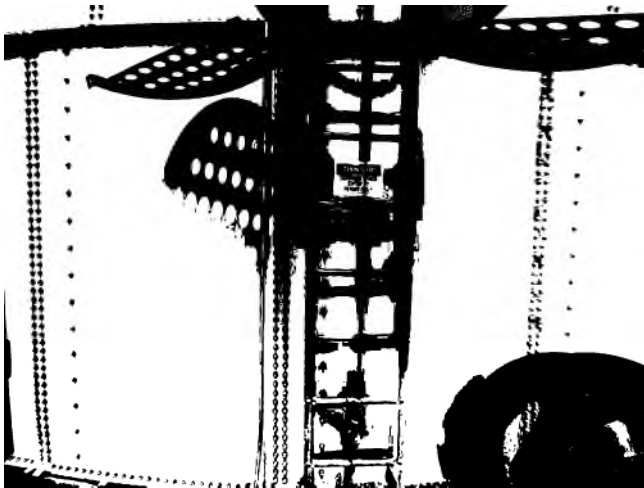
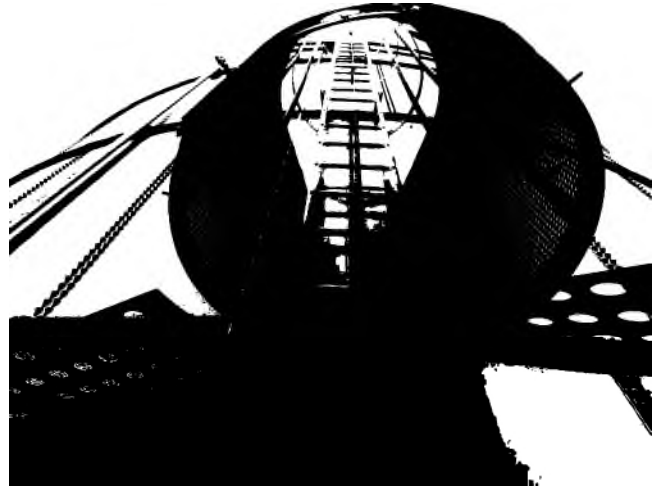
Summary: The ladder was found secure, OSHA approved and in good condition.

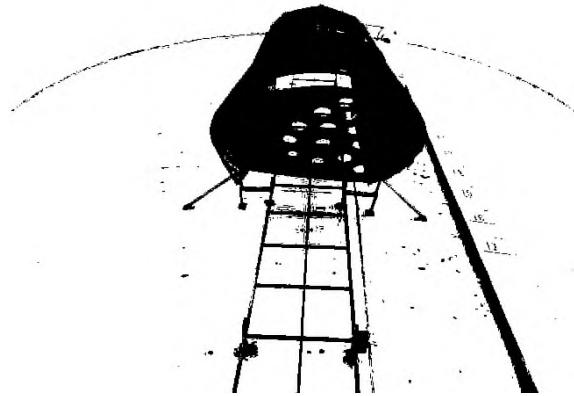
Summary: The ladder was found secure, OSHA approved and in good condition with oxidation & corrosion noted.

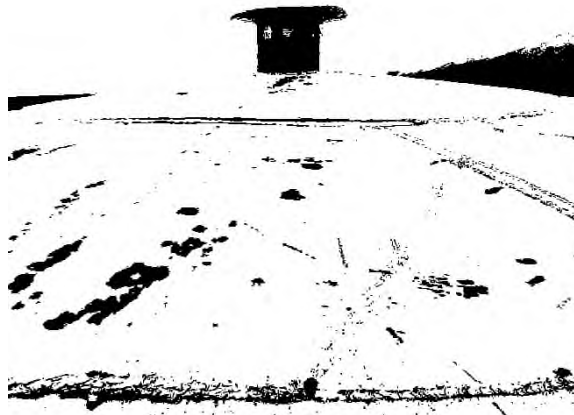
Summary: The roof was found in poor condition with oxidation, de-lamination, 30% corrosion and holes noted.

1. Schedule time for a blast and recoat or decommission the tank and replace.

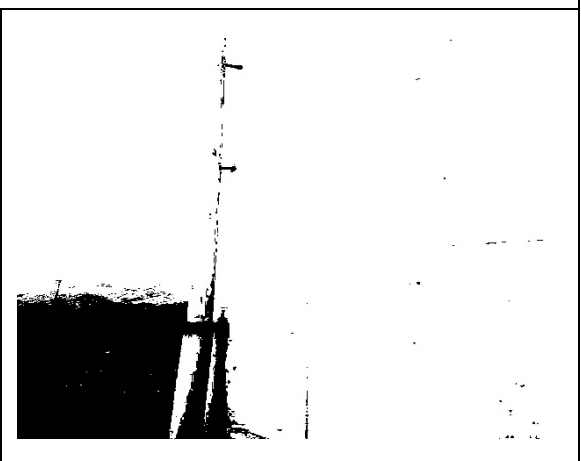
Summary: The overflow was found in fair condition with de-lamination, oxidation and 1% corrosion noted.

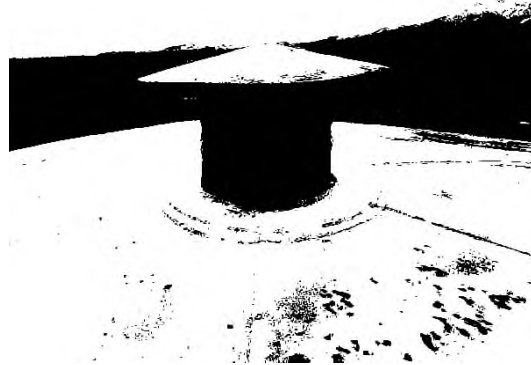
Summary: The vent was found in fair condition with de-lamination, oxidation and 10% surface corrosion noted and a screen in place.

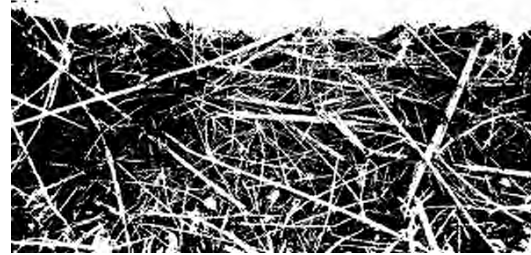
Summary: The base of the tank was found in good condition with some erosion noted.

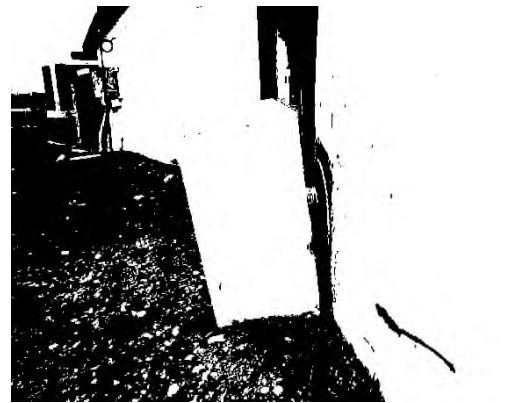
Manway Condition

Coating Condition: Poor
Weld/Seam Condition: Fair
Corrosion Present? Y N
Percentage: 5%
Pitting Noted In Metal? Y N
Depth: N/A

Summary: The manway was found secure and in fair condition with 5% surface corrosion noted.

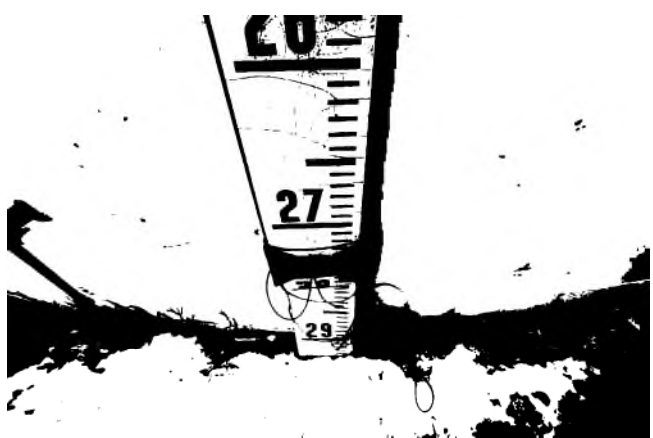
Water Level Indicator Condition

4. The overflow was found in good condition with minor sags & runs in the coating and chalking noted and is directly connected to the storm drain.
5. The water level indicator was readable but the marker and cable are detached.

Marker Condition: Good
 Attached & Accurate? Y N
 Marker Board Condition: Good/Fair
 Is the level reading visible? Y N
 Pulley Condition: Good
 Attached Properly? Y N
 Cable Condition: Fair
 Attached Properly? Y N

Summary: The water level indicator was readable but the marker and cable are detached.

1. Install a new float and then attach to the water level marker.
2. Schedule a blast and recoat of the interior as soon as budgets will allow. If, within 3 years, the recoating has not been completed, schedule a follow-up clean and inspect as recommended by the AWWA.

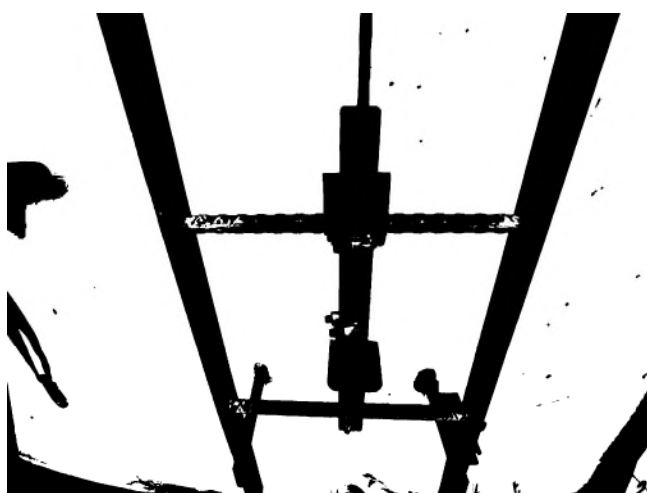
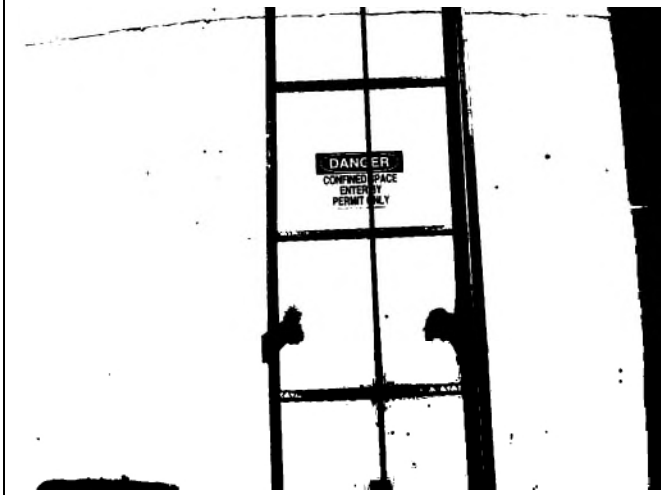
Summary: The hatch was found locked with a gasket in place and in good condition with minor staining and 0.01% uniform surface corrosion noted.

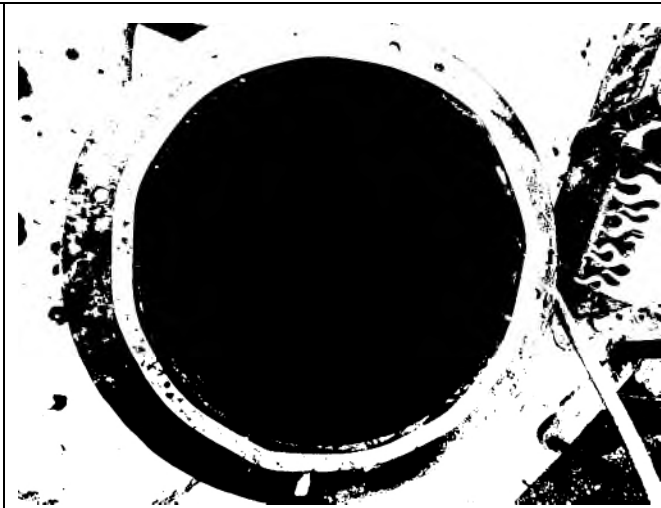
Roof Condition

Roof Type: Domed
 Coating Condition: Good/Fair
 Seams/Welds Condition: Good
 Corrosion Present? Y N
 Oxidation Present? Y N
 De-lamination Present? Y N
 Low Spots Present? Y N
 Holes in Roof? Y N
 Cathodic Protection Plates Present? Y N
 Sealed Edges: Y N N/A
 Loose Plates? Y N N/A
 Missing Plates? Y N N/A

Summary: The roof was found in good to fair condition with moderate de-lamination and 3% uniform surface corrosion noted.

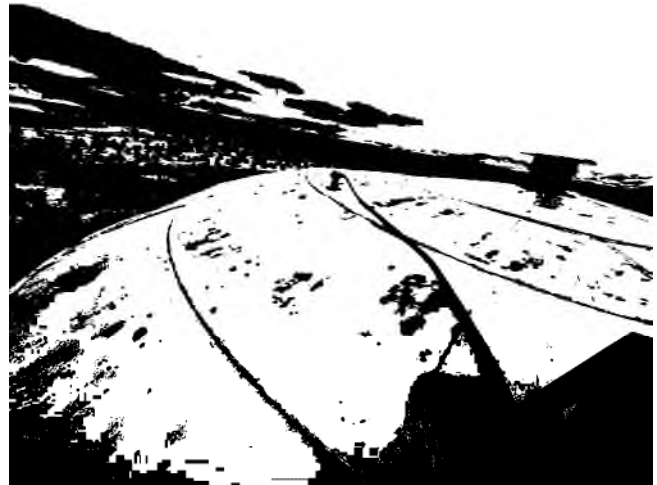
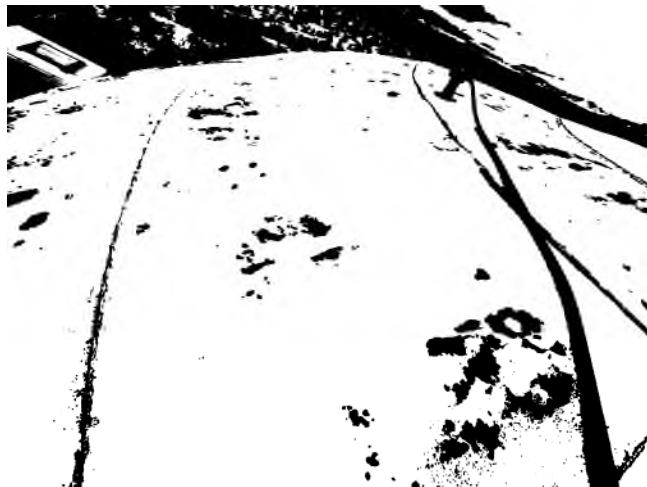
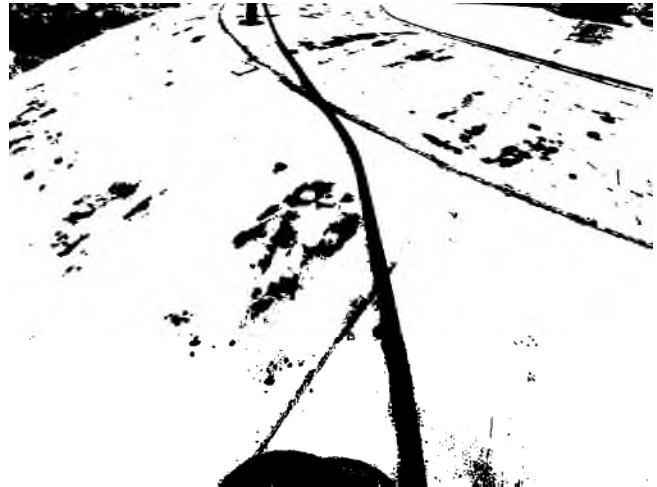
De-lamination

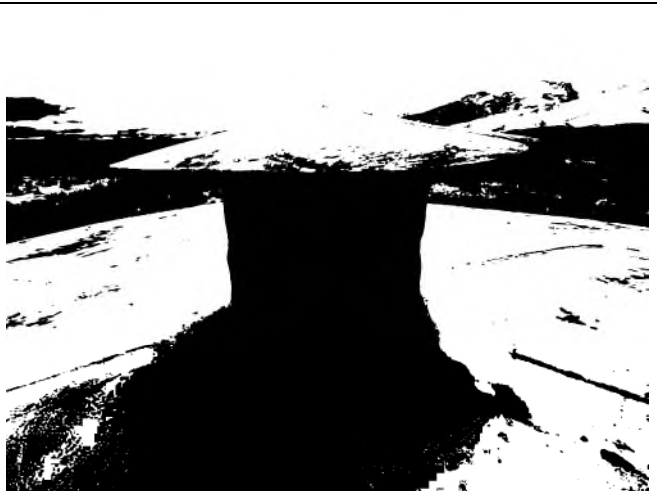
Vent Condition

Coating Condition: Good
 Seams/Welds Condition: Good
 Corrosion Present: Y N
 Oxidation Present? Y N
 De-lamination Present? Y N
 #24 Mesh Screen in Place? Y N
 Condition: Good
 All Openings Sealed? Y N
 Cap Condition: Good/Fair

Summary: The vent was found in good to fair condition with minor to moderate de-lamination noted.

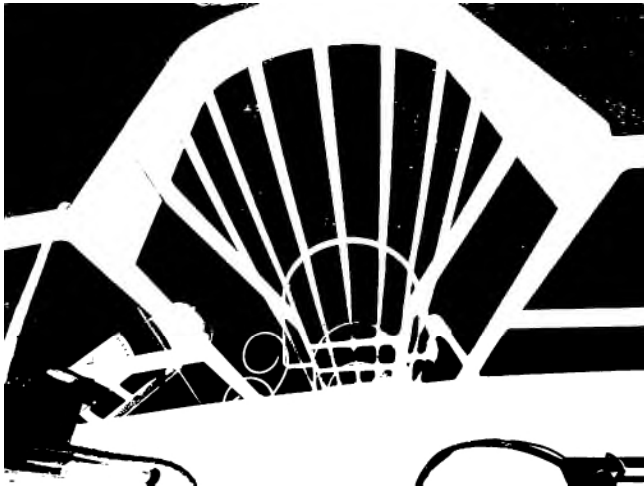
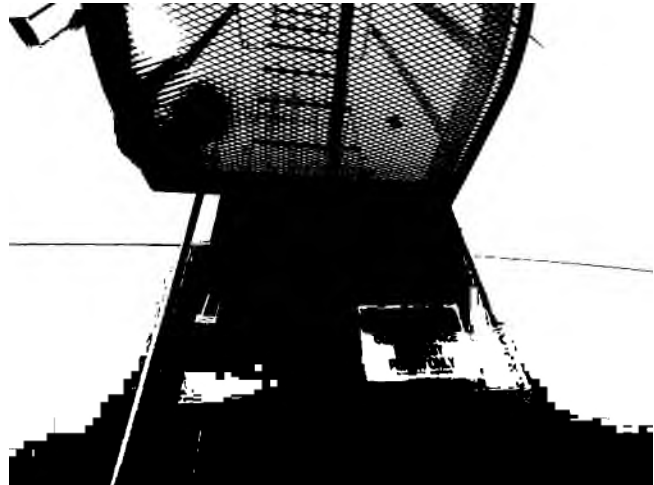
Summary: The ladder was found secure, OSHA approved and in excellent to good condition with minor chalking and 0.01% uniform surface corrosion noted.

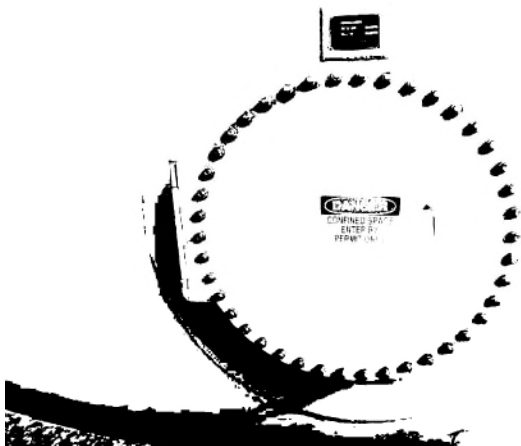
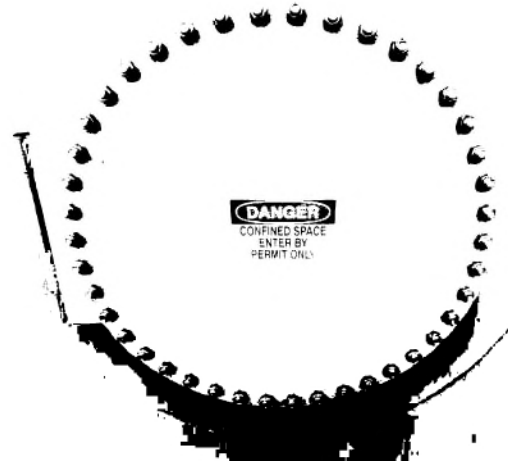
Manway Condition

Summary: The manways were found secure and in good condition with moderate chalking noted.

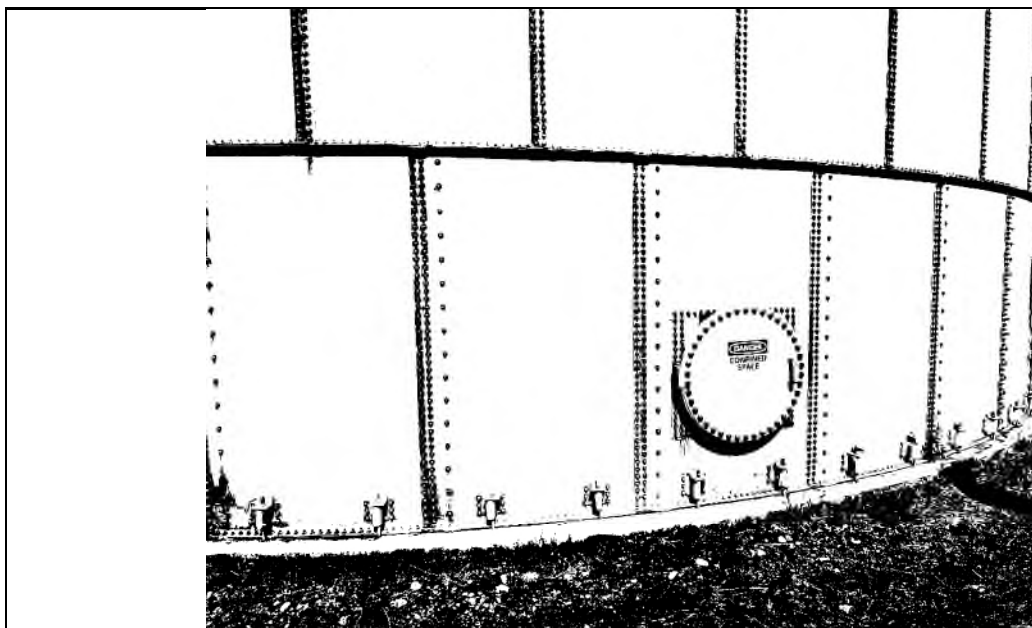
Exterior

One of two shell manways. Confined space sign is intact

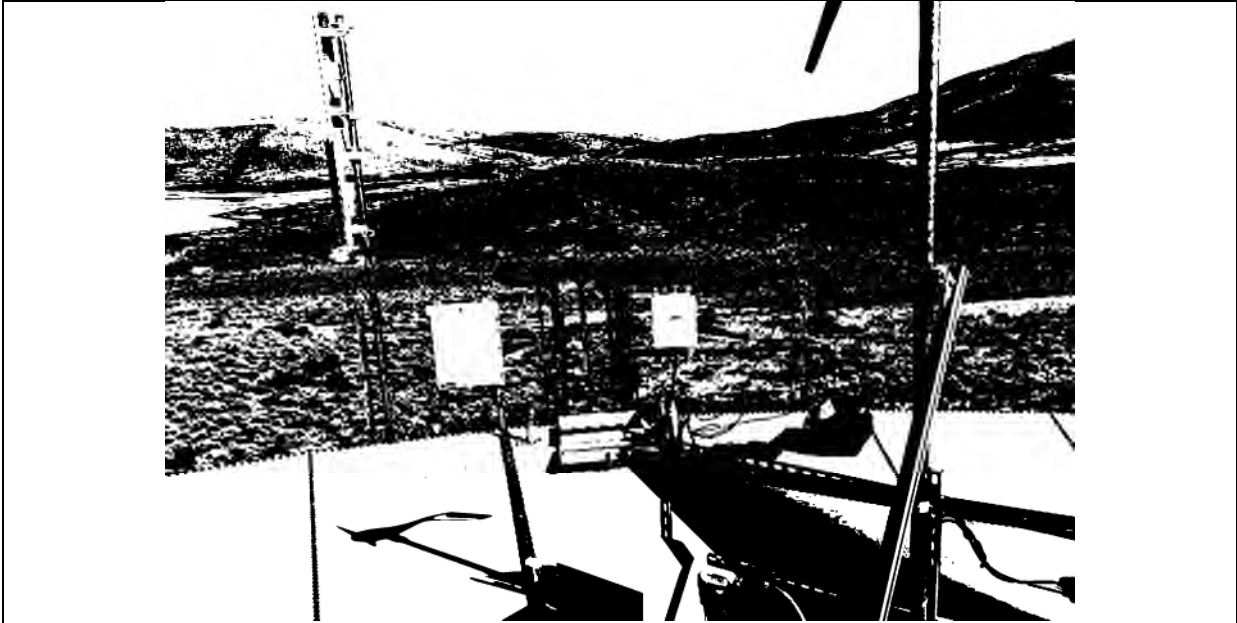
| Exterior | Roof railing is compliant but short |

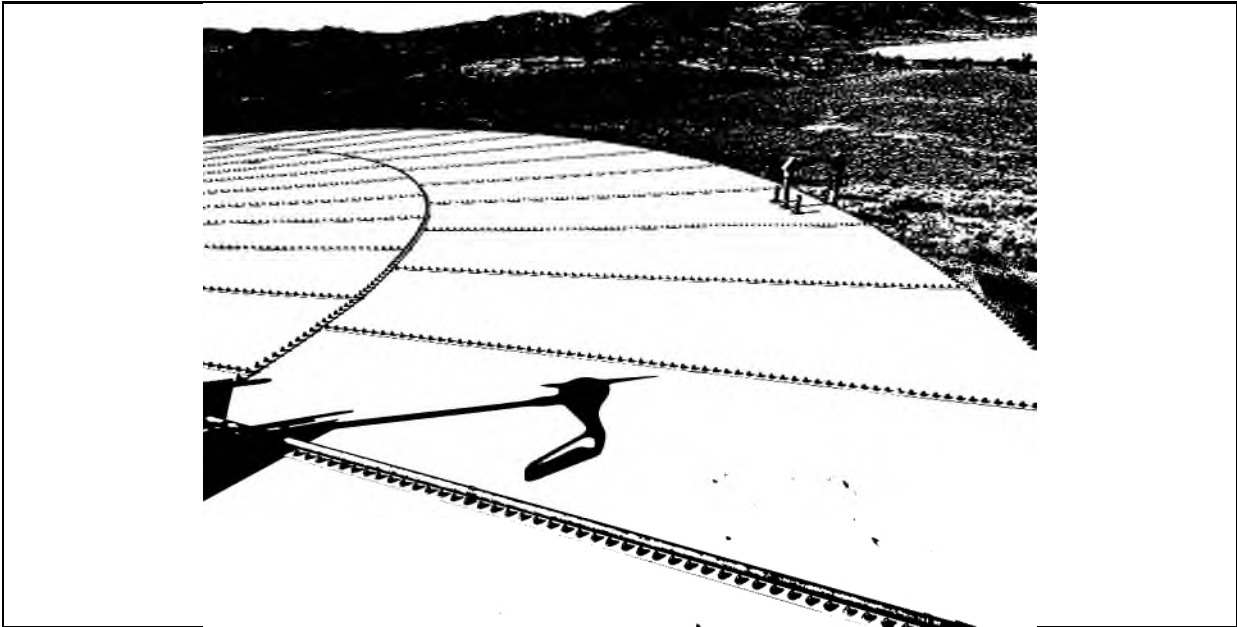
Exterior

LLI enclosed pulley system is away from the roof railing with no fall protection.

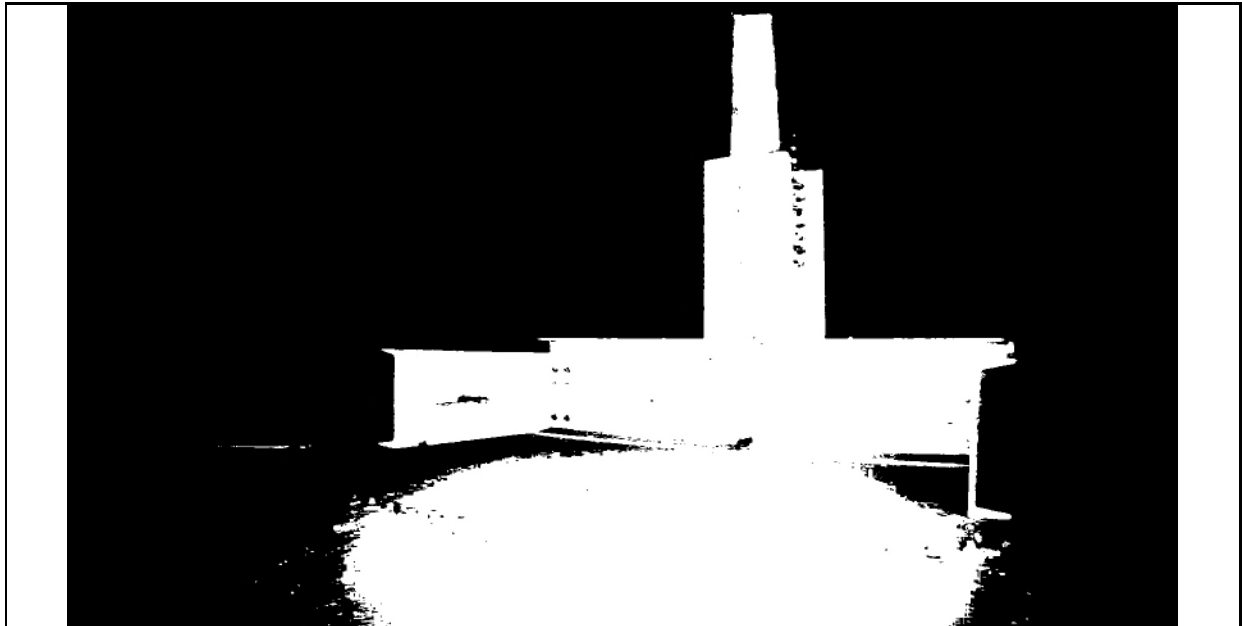
Interior

Center column base

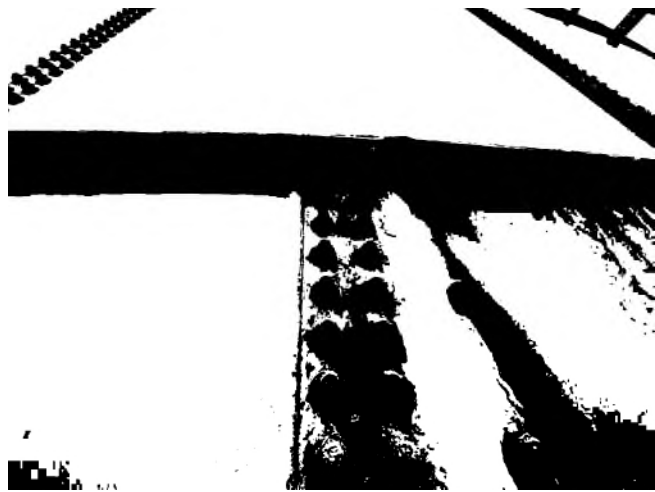
Summary: The wall was found in good condition with minor environmental growth and heavy chalking noted.

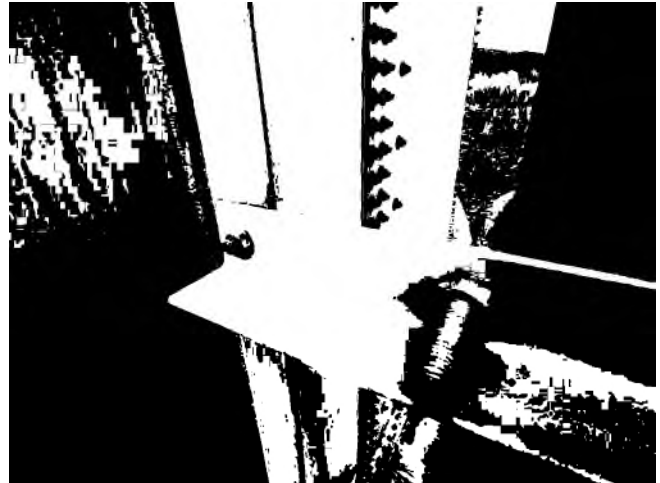
Support for overflow

Summary: The overflow was found in good condition with heavy chalking noted and is directly connected to the storm drain.

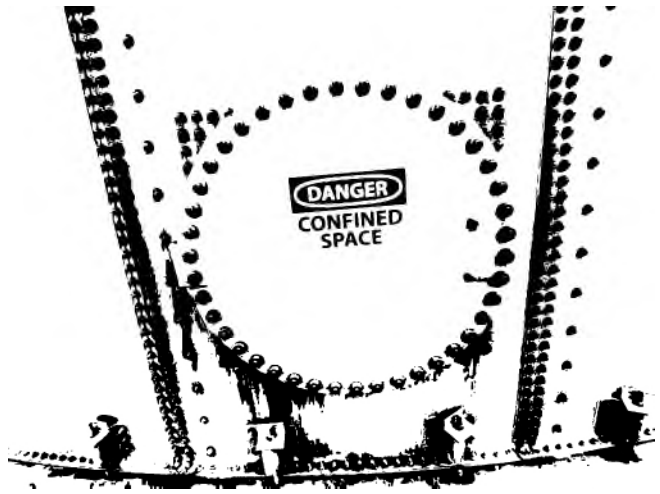
Summary: The manway was found secure and in good condition with heavy chalking noted.

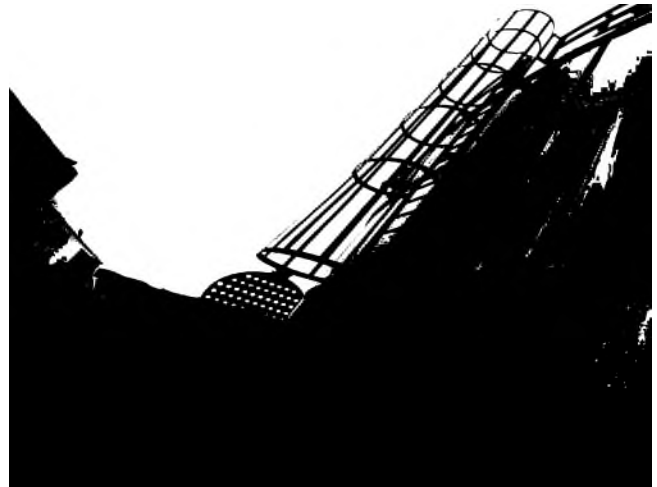
Overall picture of ladder

Summary: The ladder was found secure, OSHA approved and in good condition.

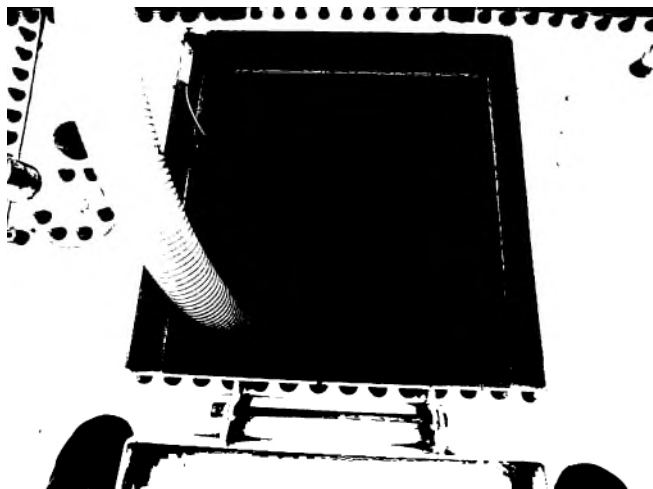
Hatch open

Summary: The hatch was found locked with no gasket present and in good condition.

1. Install a gasket on the access hatch.
2. Continue to schedule a clean and inspect every 3-5 years per AWWA recommendations.

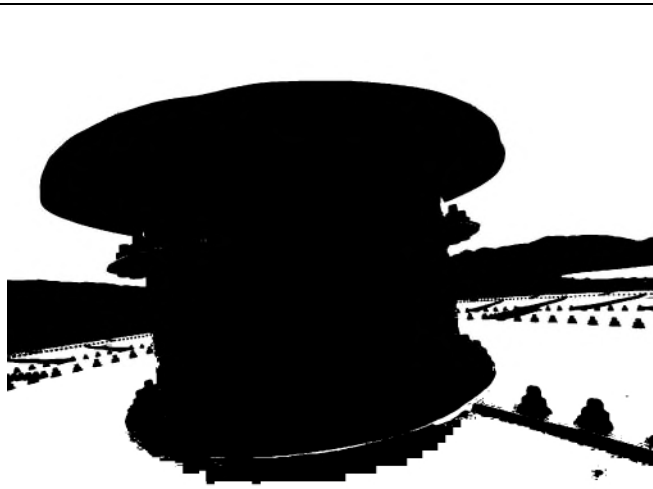
Summary: The vent was found in good condition.

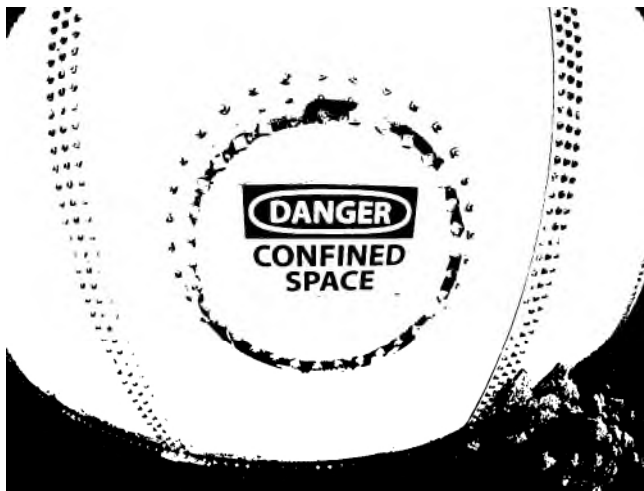
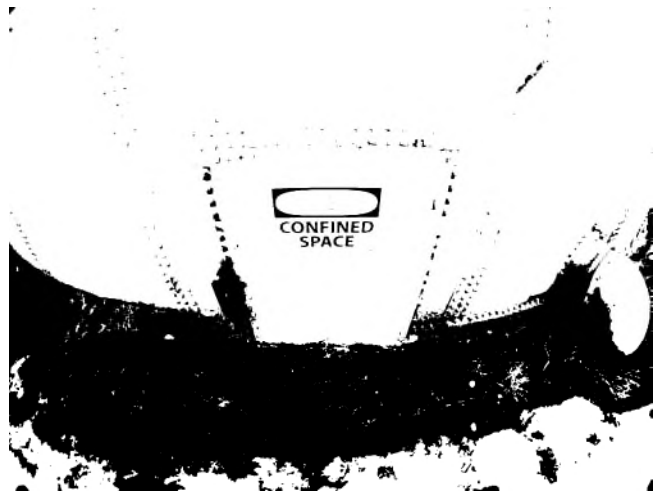
Manway Condition

Summary: The manways were found secure and in good condition with minor cracking, corrosive staining, minor to moderate de-lamination and 0.1% uniform surface corrosion noted.

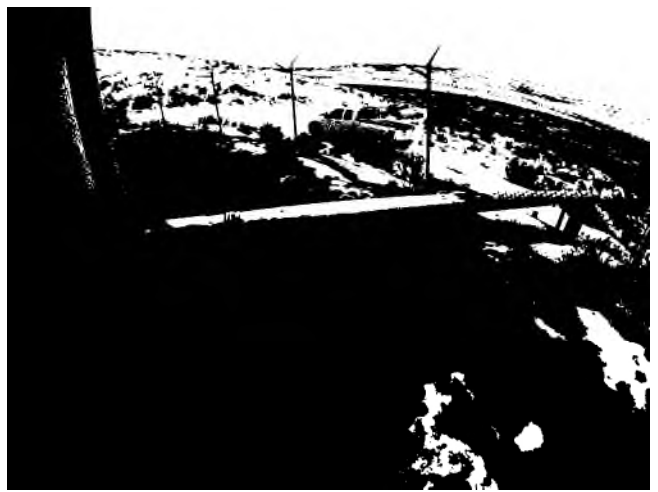
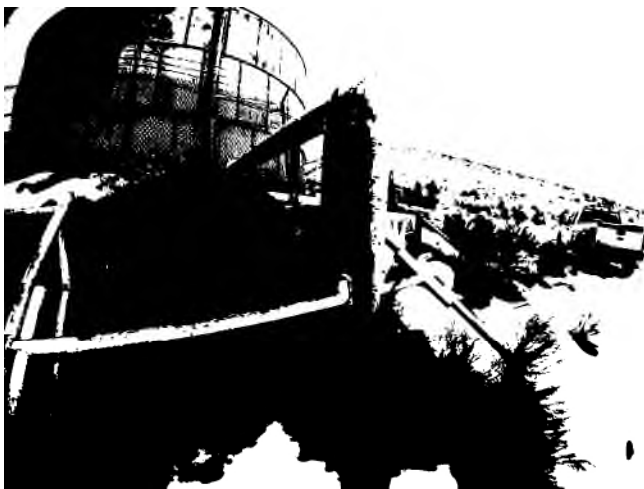
Overflow Structure Condition

Summary: The overflow was found in good condition with minor de-lamination, chalking, minor to moderate oxidation and 0.1% uniform surface corrosion noted.

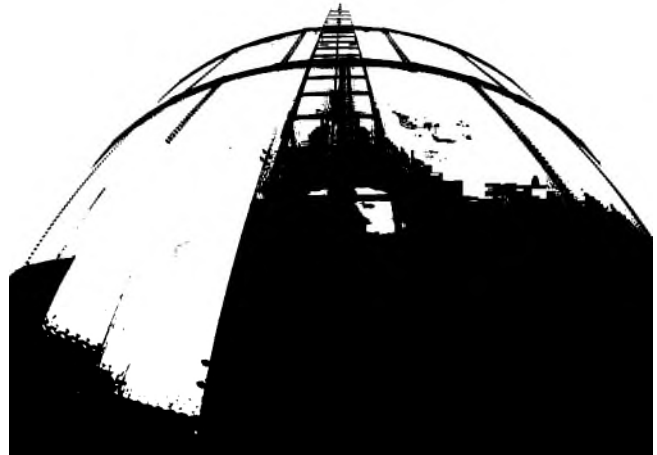
Access Ladder Condition

Summary: The ladder was found secure, OSHA approved and in good condition with minor pinholes and 0.01% uniform surface corrosion noted.

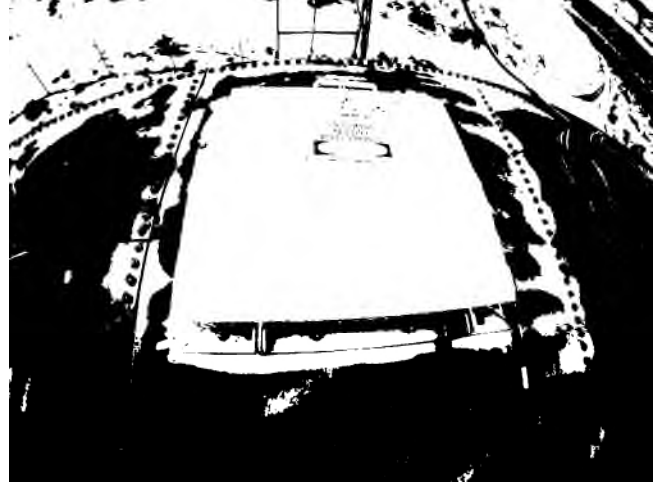
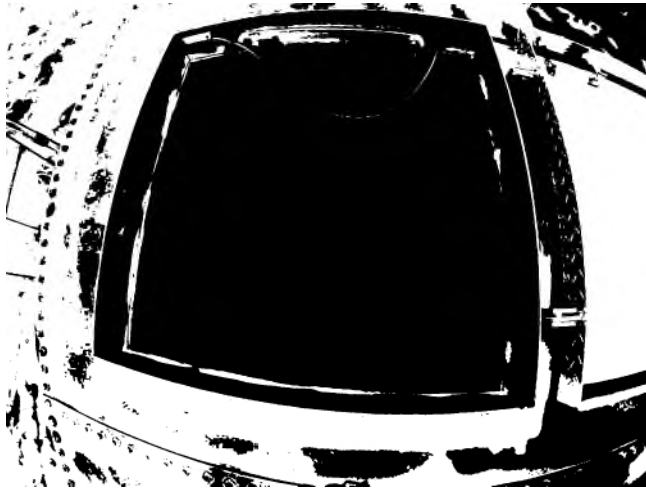
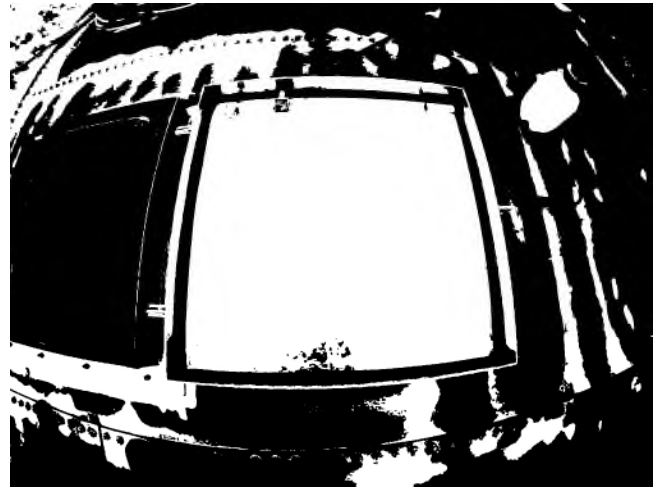
Access Hatch Condition

Summary: The aluminum hatch was found locked with a gasket in place and in good condition.

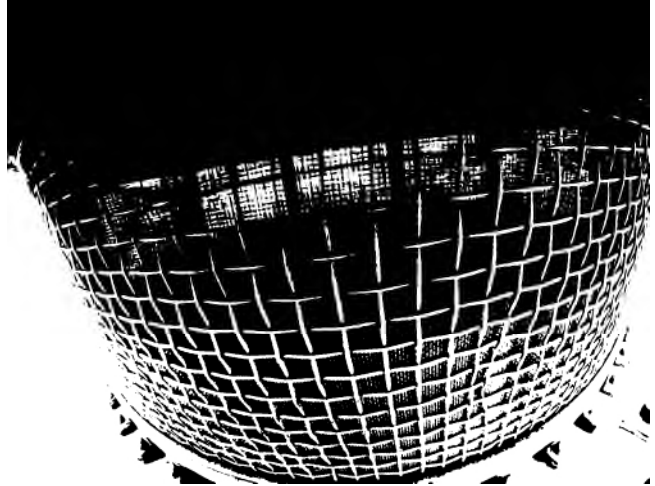
Vent Condition

Summary: The vent was found in good condition with minor de-lamination, heavy oxidation and 0.01% uniform surface corrosion noted.

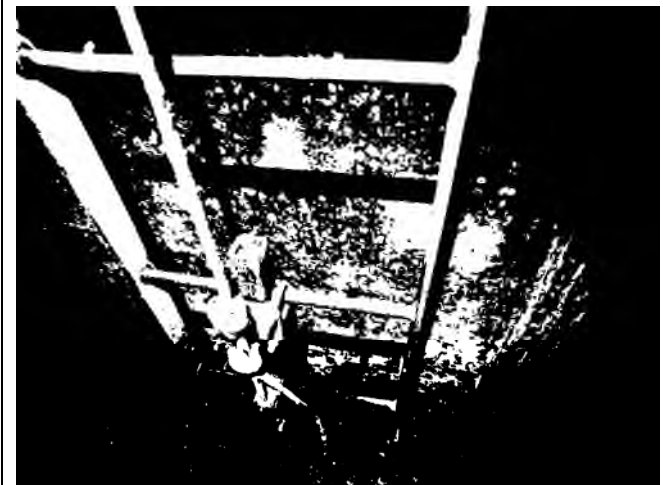
Ladder Condition

Summary: The ladder was found secure and in good condition with minor sediment staining, 1/16 inch deep pitting, 0.01% rust noduling and 0.3% uniform surface corrosion noted. The safety cable was in good condition with 0.3% uniform surface corrosion present.

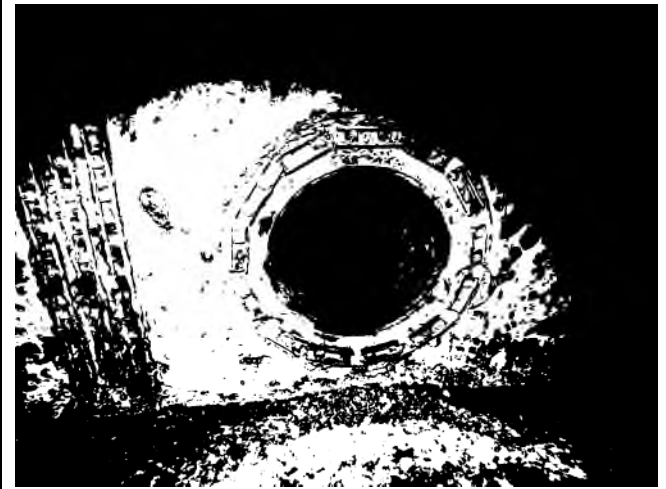
Inlet and Outlet Condition

Summary: The inlet/outlet was found in good condition with moderate sediment staining, 1/16 inch deep pitting and 0.3% rust noduling noted.

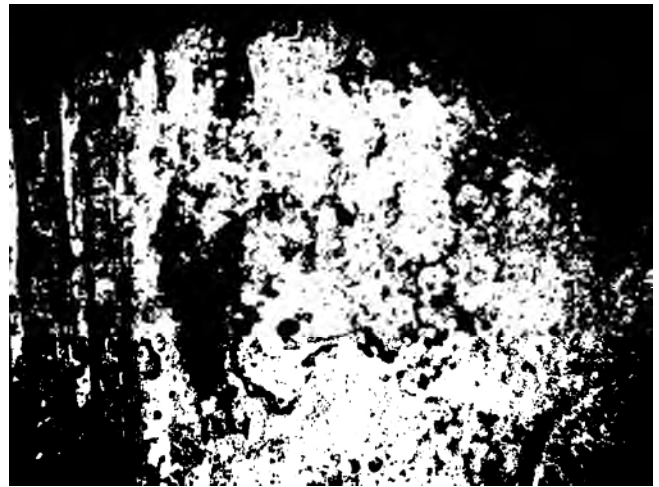
Wall Panel Condition

Summary: The interior wall was found in fair condition with moderate micro & macro blistering, de-lamination, heavy sediment & corrosive staining, 1/16 inch deep pitting, 10% uniform surface corrosion and 50% rust noduling noted.

1. Schedule a blast and recoat of the interior as soon as budgets will allow. If, within 3 years, the recoating has not been completed, schedule a follow-up clean and inspect as recommended by the AWWA.

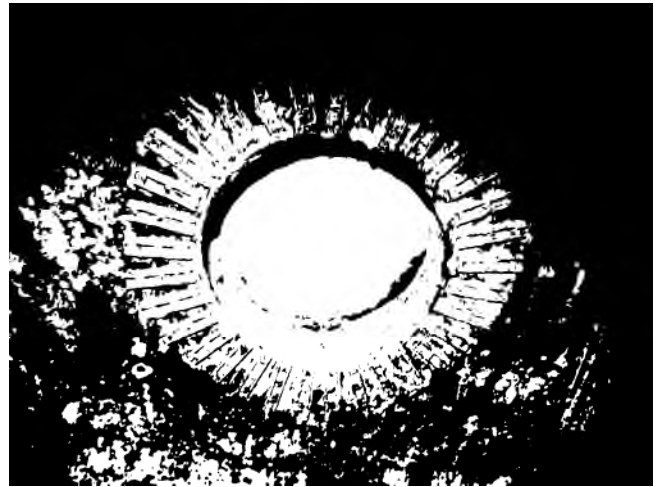
Manway Condition

Summary: The manways were found in fair condition with moderate micro & macro blistering, 1/16 inch deep pitting and 10% rust noduling noted.

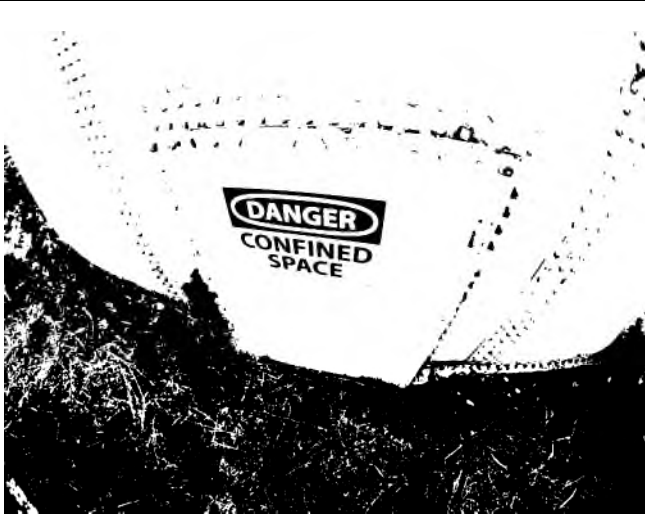
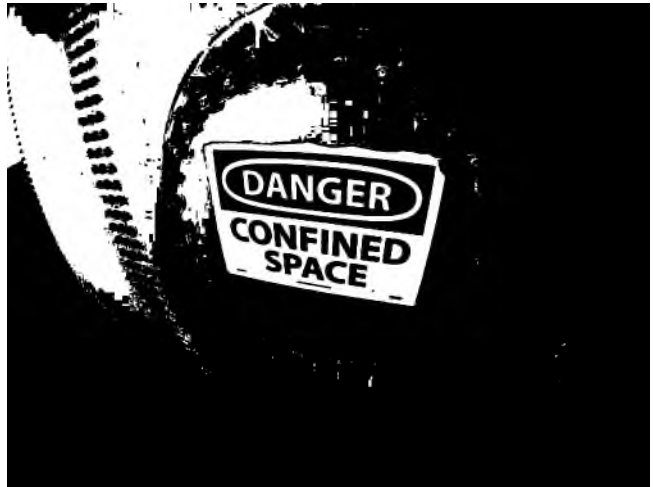
Manway Condition

Coating Condition: Both Good
 Weld/Seam Condition: Both Good
 Corrosion Present? Y N
 Oxidation Present? Y N
 De-lamination Present? Y N

Summary: The manways were found secure and in good condition with minor de-lamination, oxidation, corrosive staining and 0.01% concentrated cell corrosion & uniform surface corrosion noted.

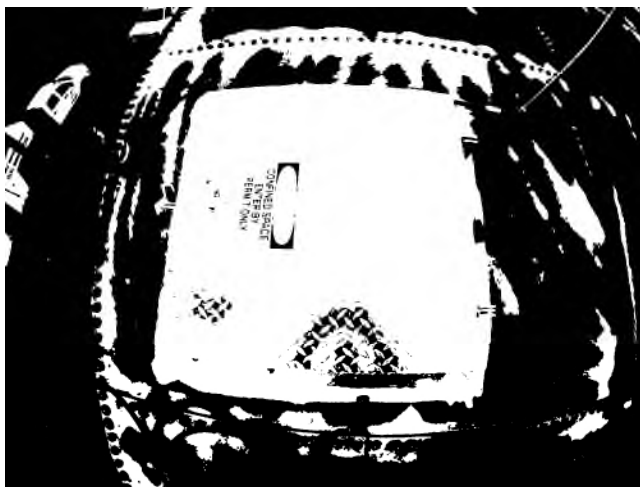
Access Hatch Condition

Coating Condition: Good
 Seams/Welds Condition: Good
 Corrosion Present: Y N
 Oxidation Present? Y N
 De-lamination Present? Y N
 Hatch Size: 2 foot square
 Riser Height: 4 inches Lid Height: 2 inches
 Hatch Locked? Y N

Hinge Condition: Good
 Gasket Present? Y N
 Intact? Y N N/A
 Insects, Dirt Or Debris Present Under Hatch? Y N

Summary: The hatch was found locked with a gasket in place and in good condition with minor oxidation and 0.01% uniform surface corrosion noted.

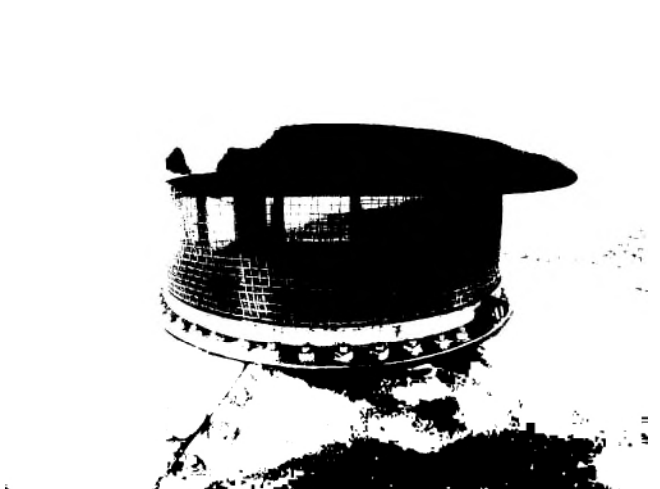
Vent Condition

Coating Condition: Good
 Seams/Welds Condition: Good
 Corrosion Present: Y N
 Oxidation Present? Y N
 De-lamination Present? Y N
 #24 Mesh Screen in Place? Y N
 Condition: Good

All Openings Sealed? Y N
 Cap Condition: Good

Summary: The vent was found in good condition with minor oxidation, moderate de-lamination and 0.03% uniform surface corrosion noted.

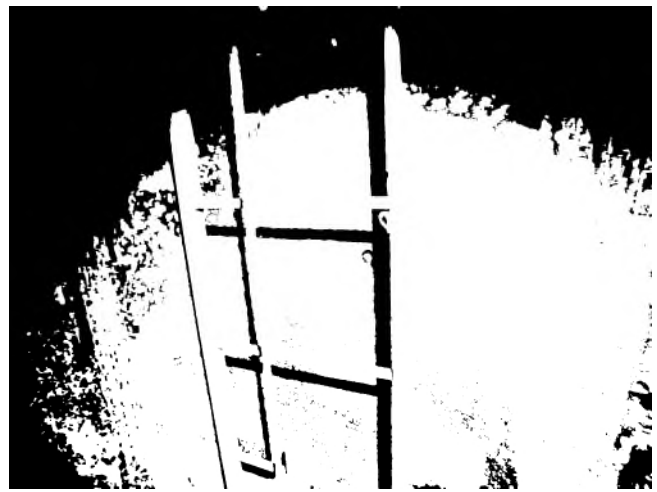
Ladder Condition

Ladder Location: 12 o'clock
 Coating Condition: Good
 Weld/Seam Condition: Good
 Supports Condition: Good
 Corrosion Present? Y N
 Oxidation Present? Y N
 De-lamination Present? Y N

Summary: The ladder was found secure and in good condition with minor chalking, corrosive & sediment staining and 0.01% concentrated cell corrosion noted.

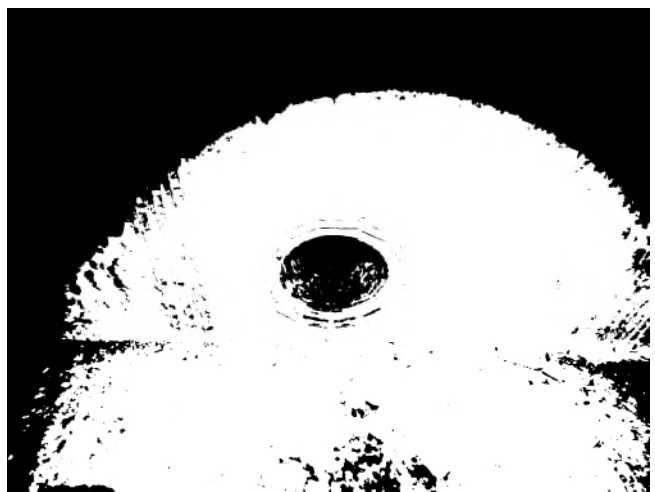
Inlet and Outlet Condition

Common Inlet/Outlet? Y N
Location: 6 o'clock
Coating Condition: Good
Weld/Seam Condition: Good
Corrosion Present? Y N
Oxidation Present? Y N
De-lamination Present? Y N

Summary: The common inlet/outlet was found in good condition with heavy corrosive staining, pitting and 1% rust noduling & uniform surface corrosion noted.

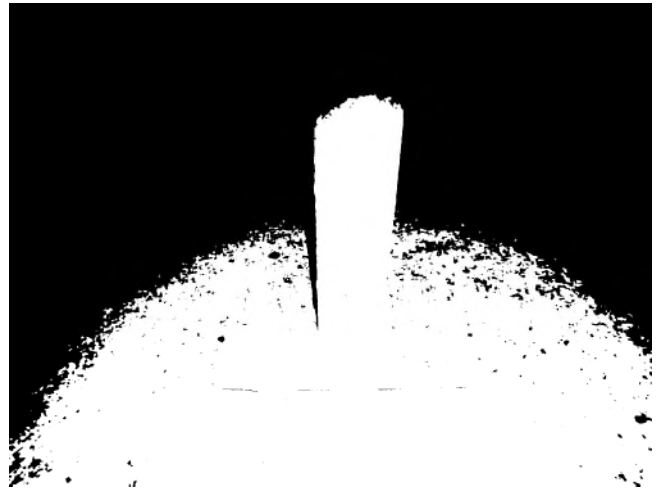
Support Column Condition

Number Of Columns: 1
 Coating Condition: Fair
 Welds/seam Condition: Good
 Corrosion Present? Y N
 Oxidation Present? Y N
 De-lamination Present? Y N

Summary: The support column was found secure and in good condition with minor chalking, heavy corrosive & sediment staining, pitting and 1% uniform surface corrosion & rust noduling noted.

1. Continue to schedule a clean and inspect every 3-5 years per AWWA recommendations.

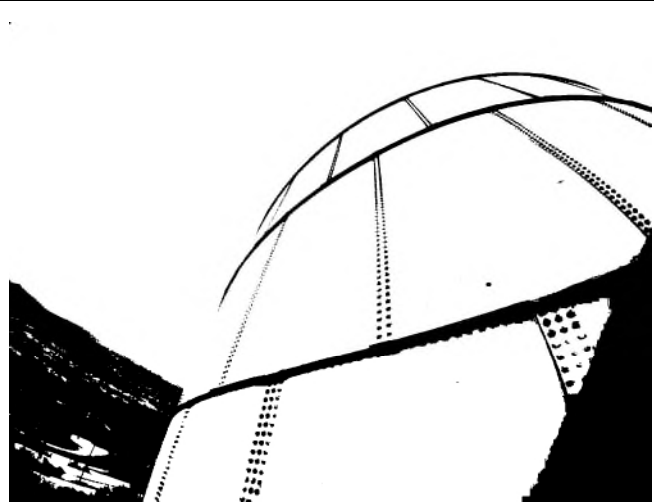
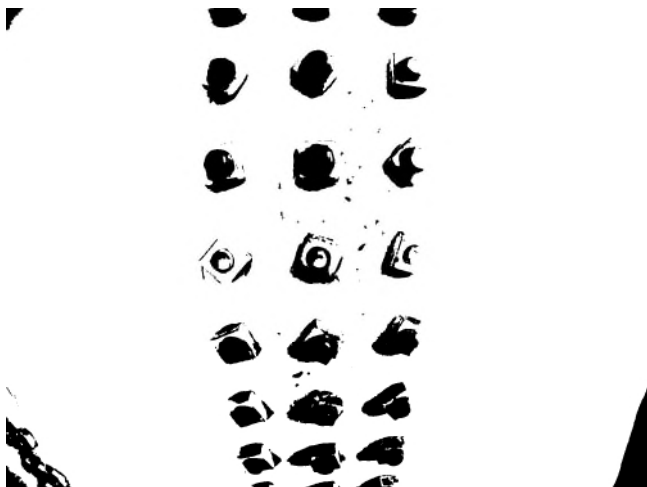
Wall Panel Condition

Coating Condition: Good
 Seams/Welds Condition: Good
 Corrosion Present? Y N
 Oxidation Present? Y N
 De-lamination Present? Y N
 Dents Present? Y N
 Holes Present? Y N
 Signs Of Leaking? Y N

Summary: The wall was found in good condition with minor oxidation, de-lamination, staining, chalking and 0.03% uniform surface corrosion noted.
