BEFORE THE PUBLIC UTILITIES COMMISSION OF NEVADA

Application of Great Basin Water Co., Pahrump, Spring Creek, Cold Springs, Pahrump, and Spanish Springs Divisions for Approval of its 2024 Integrated Resource Plan and to designate certain system improvement projects as eligible projects for which a system improvement rate may be established, and for relief properly related thereto.

VOLUME 8 OF 18

**Inspection Report for
Great Basin Water Company
Reno, NV**

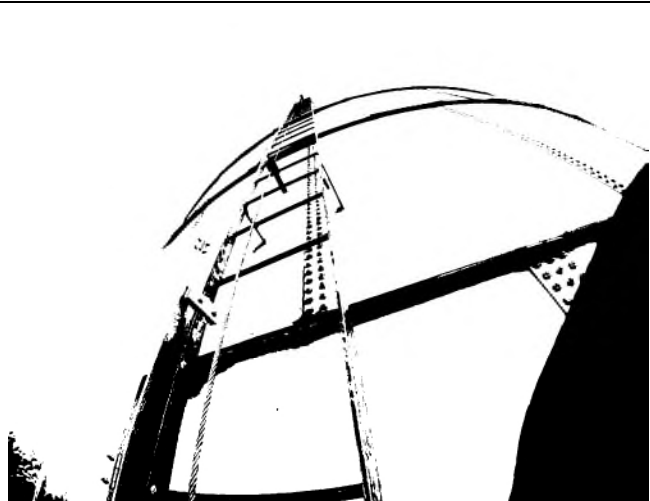
Access Ladder Condition

Ladder Type: Steel bolted
 Is Ladder and Safety Climb OSHA Approved? Y N
 Is Vandal Guard Present? Y N
 Locked? Y N N/A
 Safety Climb Type: Rail
 Safety Climb Condition: Good
 Is Top Of Tank Easily Accessible? Y N
 Coating Condition: Good
 Seams/Welds Condition: Good
 Stand Off Supports Condition: Good
 Corrosion Present? Y N
 Oxidation Present? Y N
 De-lamination Present? Y N

Summary: The ladder was found secure, OSHA approved and in good condition.

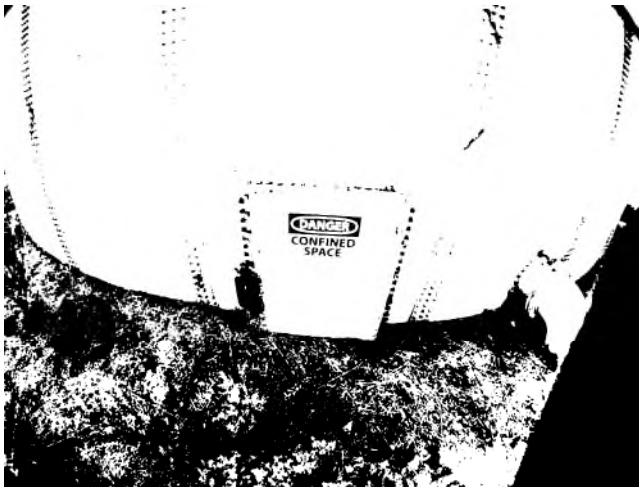
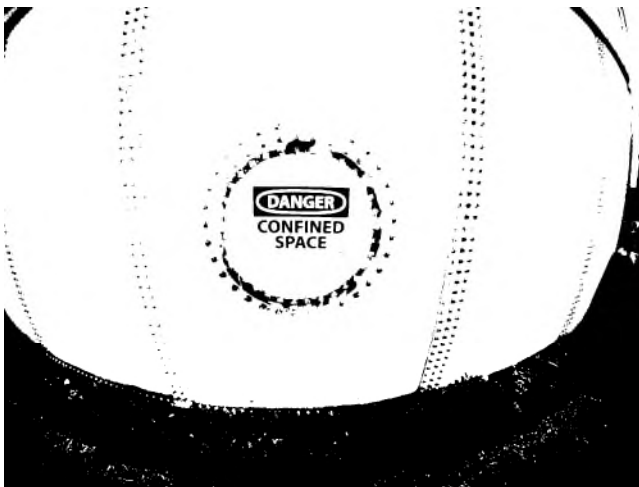
Manway Condition

Coating Condition: Both Good
Weld/Seam Condition: Both Good
Corrosion Present? Y N
Oxidation Present? Y N
De-lamination Present? Y N

Summary: The manways were found secure and in good condition with minor chalking, oxidation and 0.03% uniform surface corrosion noted.

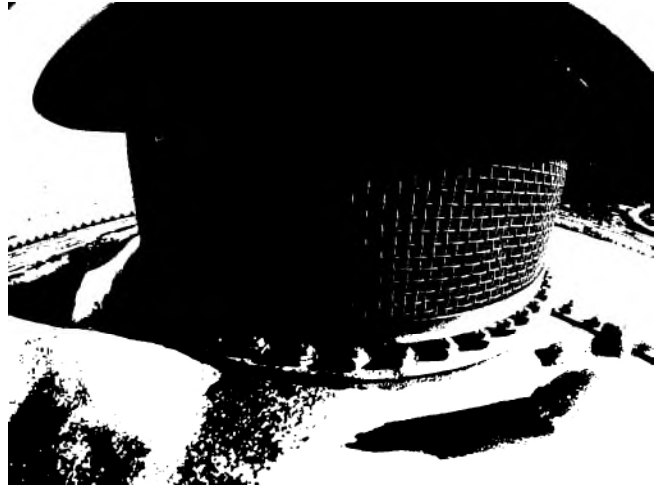
Vent Condition

Summary: The vent was found in good condition with minor staining, minor to moderate oxidation and 0.1% uniform surface corrosion noted.

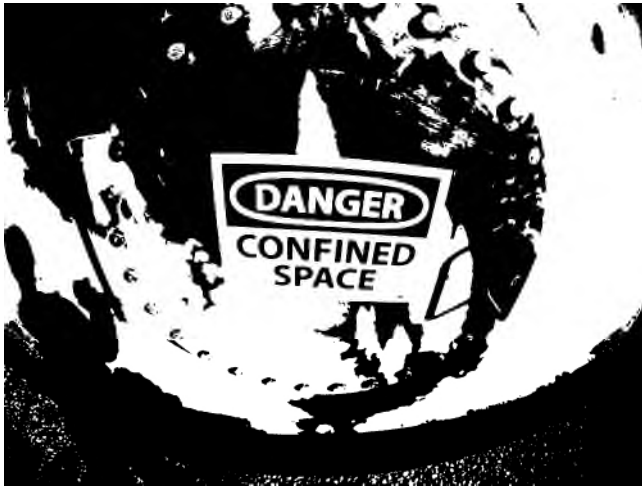
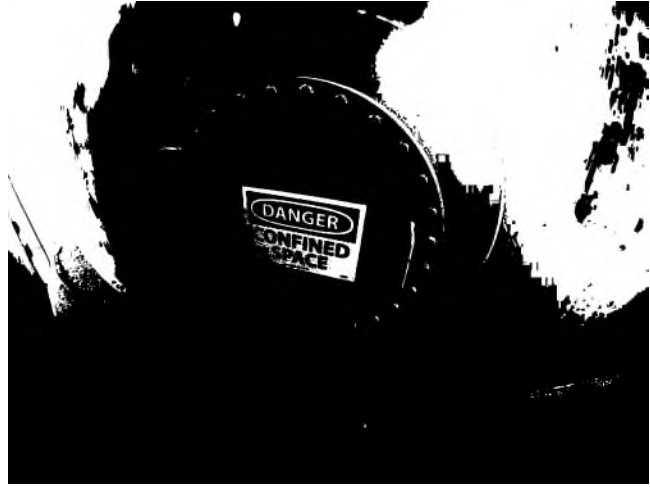
Manway Condition

Summary: The manways were found in good condition with moderate de-lamination, minor staining and chalking noted.

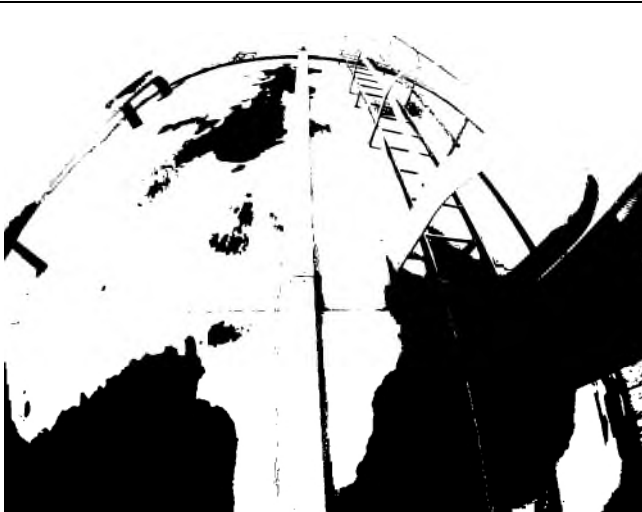
Water Level Indicator Condition

Summary: The marker board was found in poor condition. The marker, cable and pulley hardware are missing.

1. Reattach the float cable and replace the marker.
2. Continue to schedule a clean and inspect every 3-5 years per AWWA recommendations.

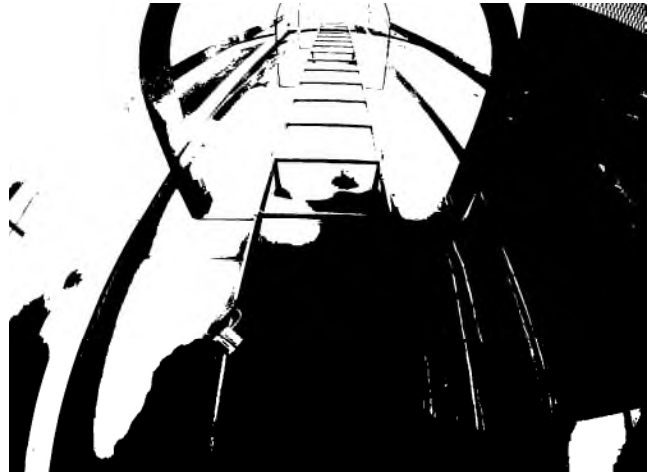
Access Ladder Condition

Summary: The ladder was found secure, OSHA approved and in good condition.

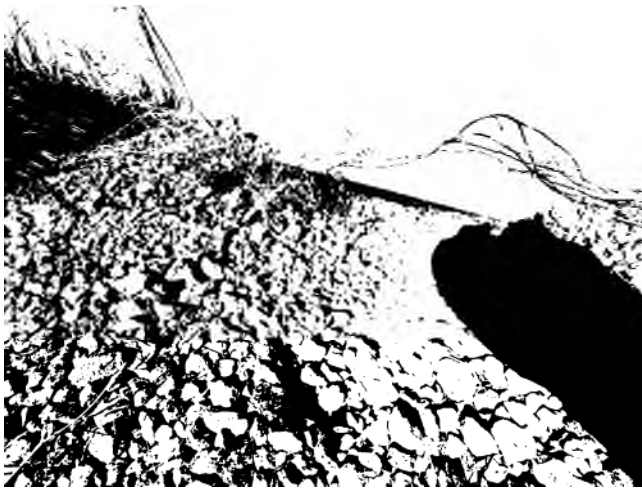
Foundation Condition

Summary: The base of the tank was found in good condition.

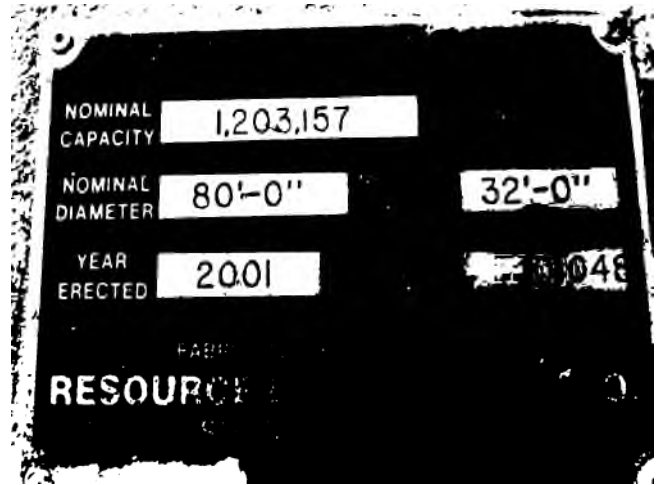
Wall Panel Condition

Summary: The wall was found in good condition with minor de-lamination and moderate chalking noted.

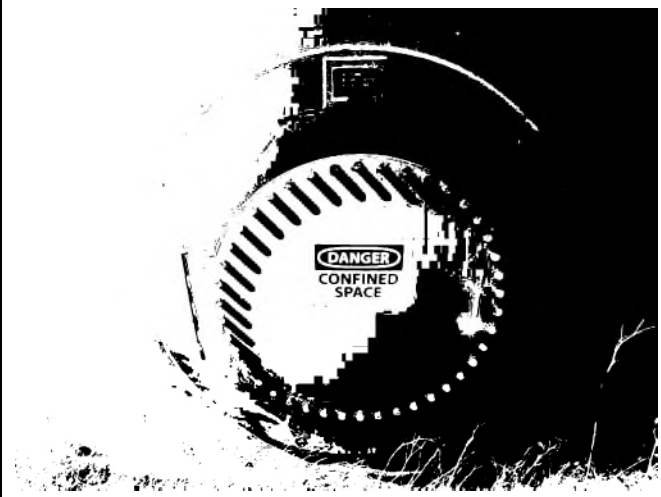
Manway Condition

Summary: The manway was found secure and in good condition with minor de-lamination noted.

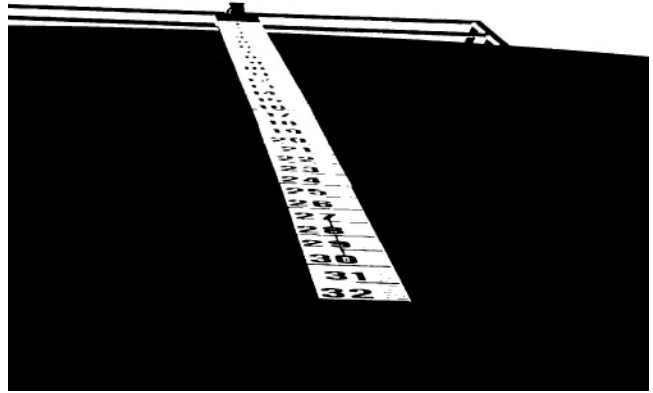
Summary: The water level indicator board is readable but the marker is missing. Loose cable dangling next to board.

1. Install a gasket on the access hatch.
2. Install a new marker on the water level indicator board and attach cable to the float.
3. Schedule a blast and recoat of the interior as soon as budgets will allow. If, within 3 years, the recoating has not been completed, schedule a follow-up clean and inspect as recommended by the AWWA.

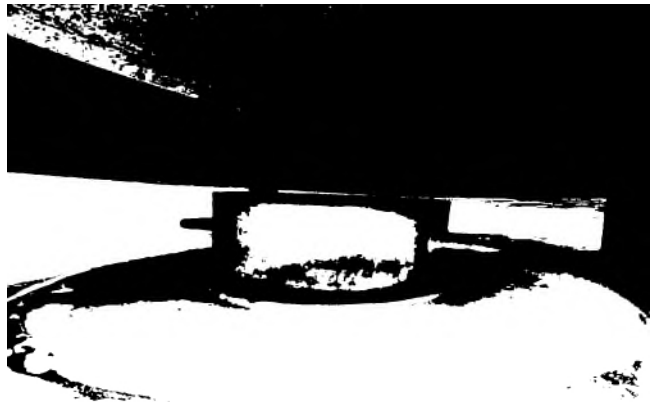
Summary: The outlet was found in good condition with heavy staining noted.

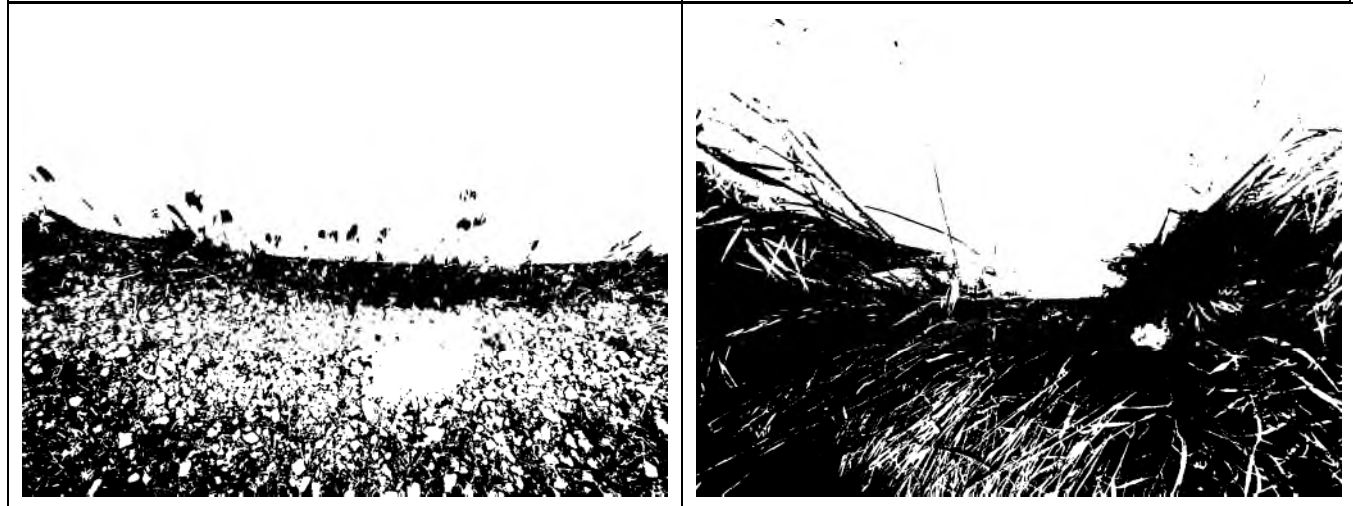
| Foundation Exposed? Y <input type="checkbox"/> N <input checked="" type="checkbox"/> Anchor Bolts Present? Y <input type="checkbox"/> N <input checked="" type="checkbox"/> Corrosion on Anchor Bolts Present? Y <input type="checkbox"/> N <input type="checkbox"/> N/A <input checked="" type="checkbox"/> Anchor Bolts Loose? Y <input type="checkbox"/> N <input type="checkbox"/> N/A <input checked="" type="checkbox"/> Cracking Noted In Foundation? Y <input type="checkbox"/> N <input type="checkbox"/> N/A <input checked="" type="checkbox"/> | Spalling Noted? Y <input type="checkbox"/> N <input type="checkbox"/> N/A <input checked="" type="checkbox"/> Summary: The base of the tank was found in good condition. |

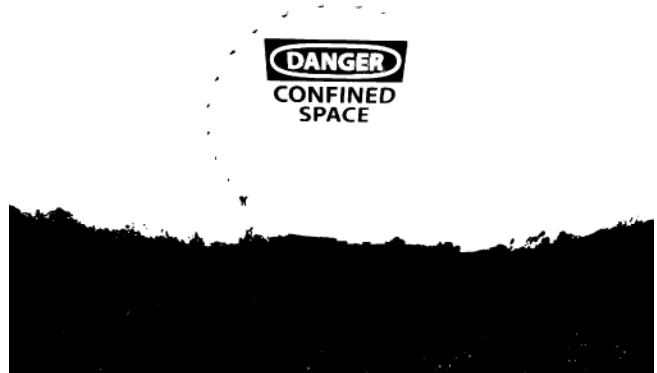
Summary: The manway was found secure and in good condition with minor chalking and 0.01% uniform surface corrosion noted.

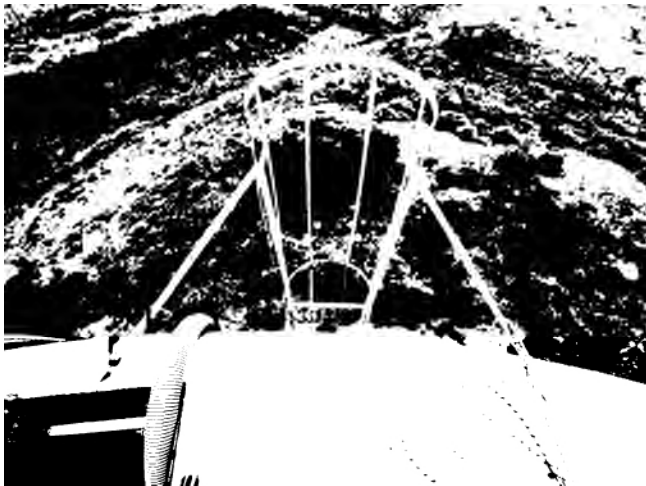
Upper section of safety cage

Summary: The ladder was found secure, OSHA approved and in good condition with minor de-lamination and chalking noted.

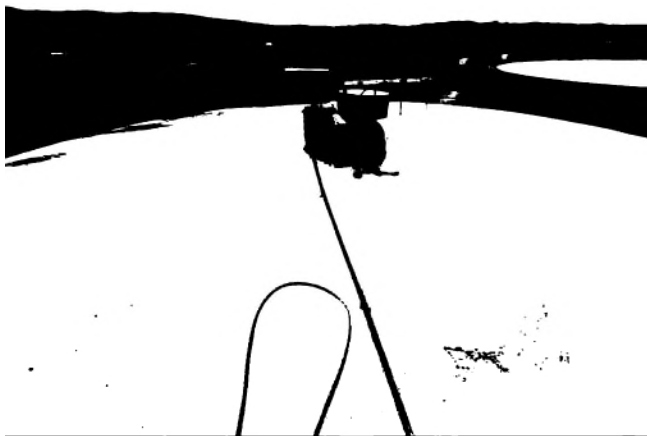
Overall view of roof

Summary: The roof was found in good condition with minor staining and chalking noted.

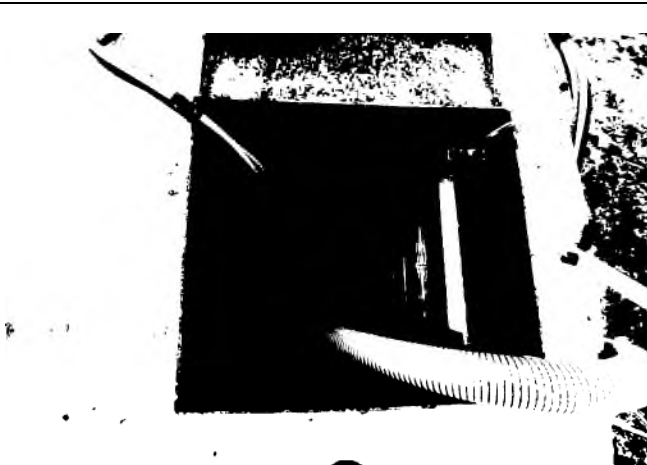
Hatch open

Summary: The hatch was found locked with no gasket in place and in good condition with minor de-lamination and 0.1% uniform surface corrosion noted.

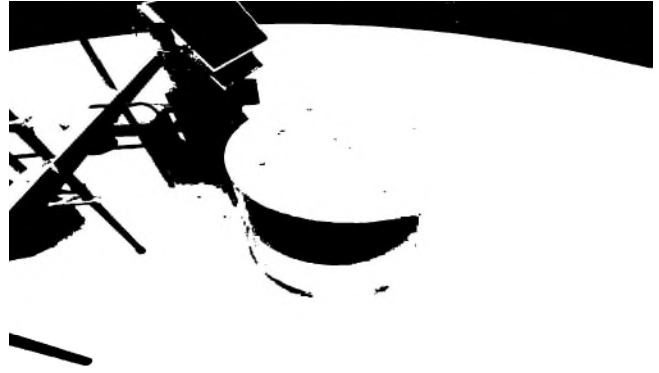
Summary: The vents were found in good condition with minor de-lamination noted.

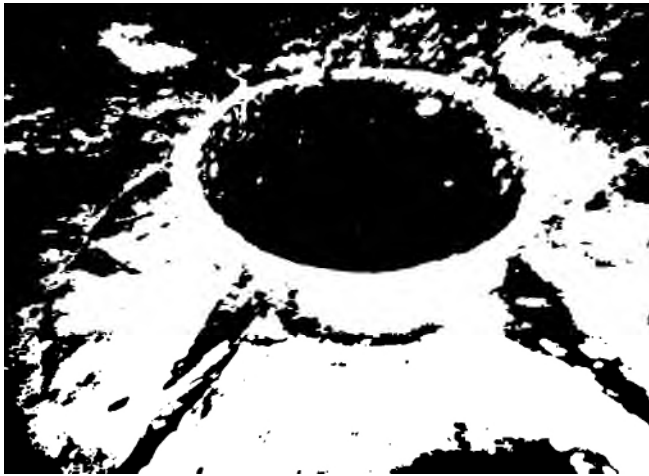
Summary: The inlet was found in fair to poor condition with heavy de-lamination, blistering and greater the 50% rust noduling noted.

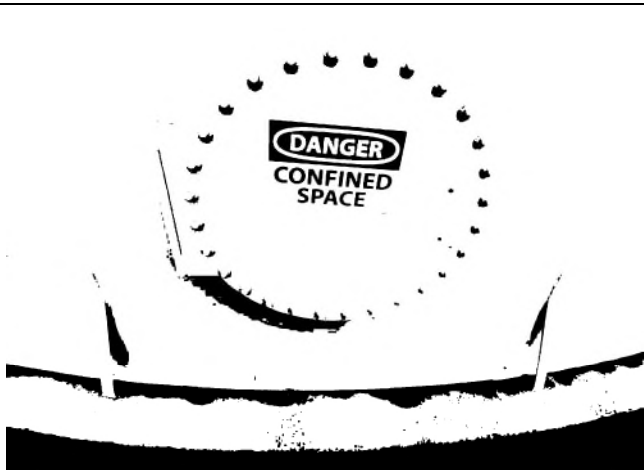
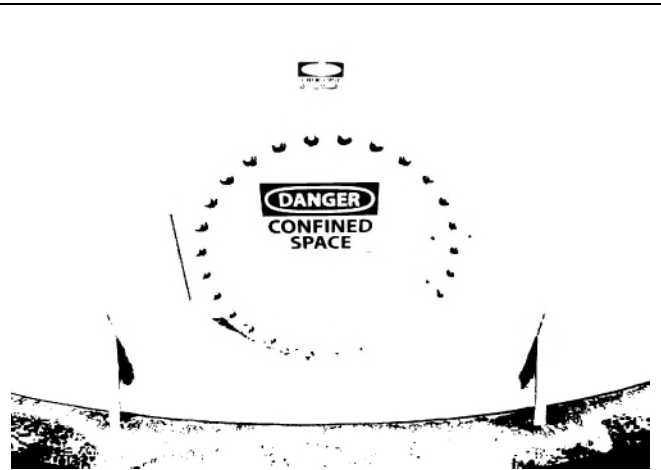
Summary: The manways were found secure and in good condition with minor chalking noted.

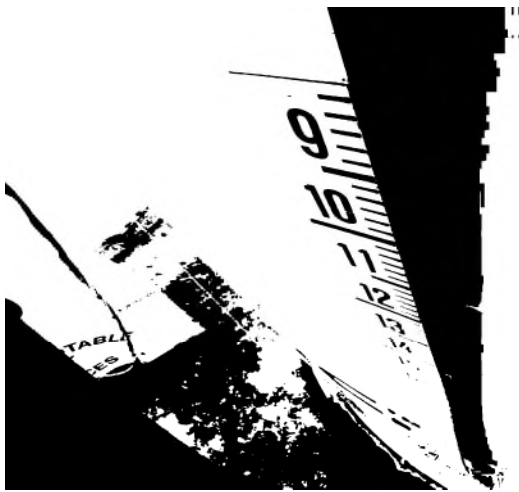
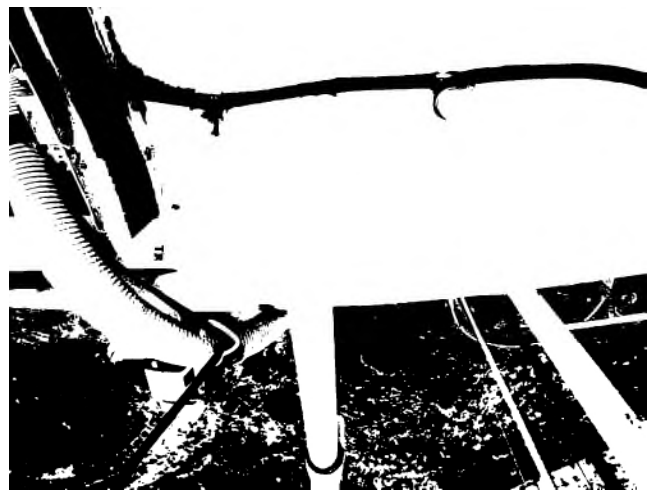
Marker pulley

Summary: The water level indicator was found in poor condition with no cable attached.

1. Install a gasket on the access hatch.
2. Install a new marker on the water level indicator board and then attach the marker to the float.
3. Continue to schedule a clean and inspect every 3-5 years per AWWA recommendations.

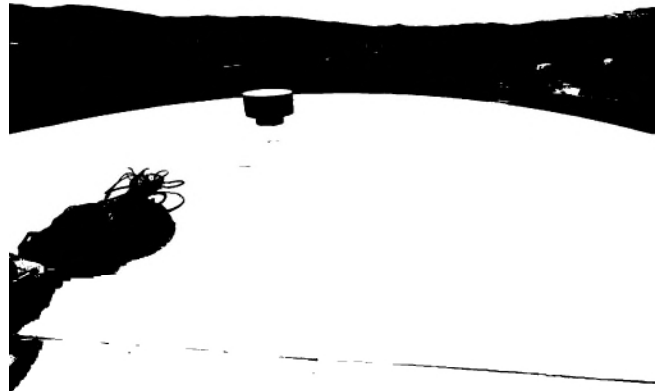
Summary: The roof was found in good condition with moderate chalking noted.

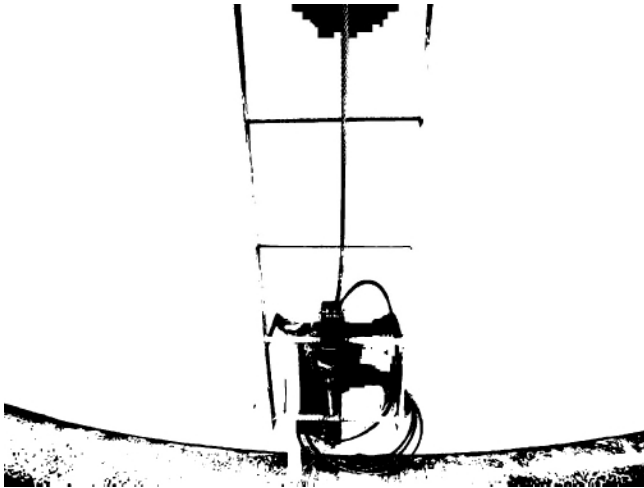
Ladder overall

Summary: The ladder was found secure, OSHA approved and in good condition with minor sags & runs in the coating and chalking noted.

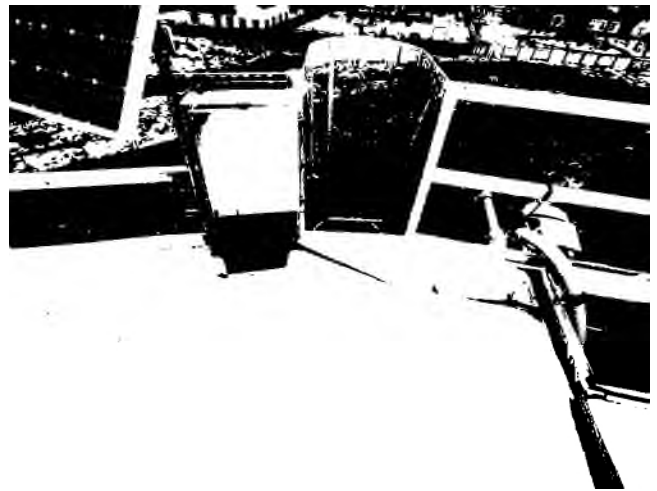
9. The hatch was found locked with no gasket present and in good to fair condition with minor to moderate de-lamination, moderate staining, chalking and 10% uniform surface corrosion noted.

Summary: The hatch was found locked with no gasket present and in good to fair condition with minor to moderate de-lamination, moderate staining, chalking and 10% uniform surface corrosion noted.

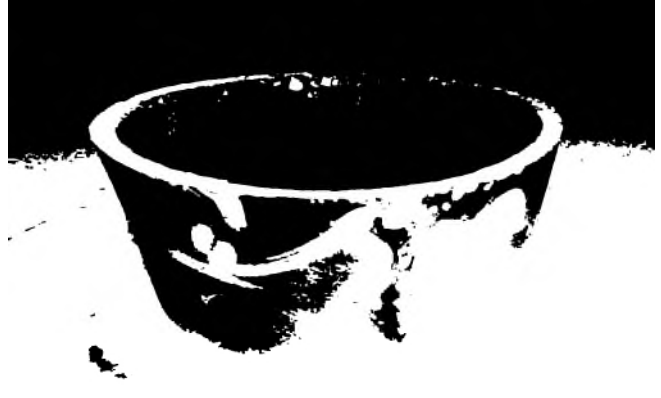
Summary: The outlet was found in good condition with minor blistering, heavy staining and 1% rust noduling noted.

Outlet overall

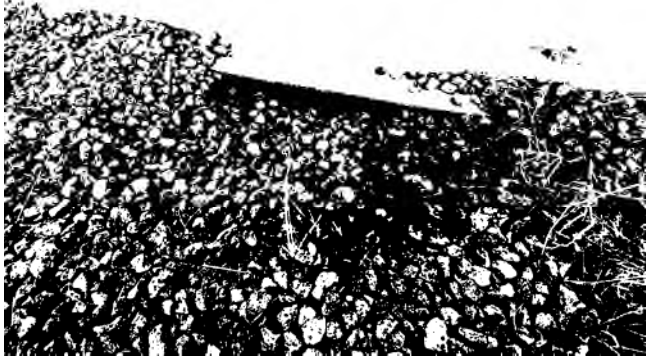
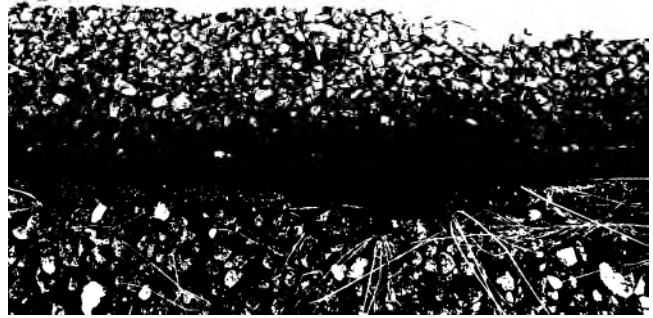
| Foundation Condition | |
|---|--|
| Foundation Exposed? Y <input type="checkbox"/> N <input checked="" type="checkbox"/> Anchor Bolts Present? Y <input type="checkbox"/> N <input checked="" type="checkbox"/> Corrosion on Anchor Bolts Present? Y <input type="checkbox"/> N <input type="checkbox"/> N/A <input checked="" type="checkbox"/> Anchor Bolts Loose? Y <input type="checkbox"/> N <input type="checkbox"/> N/A <input checked="" type="checkbox"/> | Cracking Noted In Foundation? Y <input type="checkbox"/> N <input type="checkbox"/> N/A <input checked="" type="checkbox"/> Spalling Noted? Y <input type="checkbox"/> N <input type="checkbox"/> N/A <input checked="" type="checkbox"/> Summary: The base of the tank was found in good condition. |

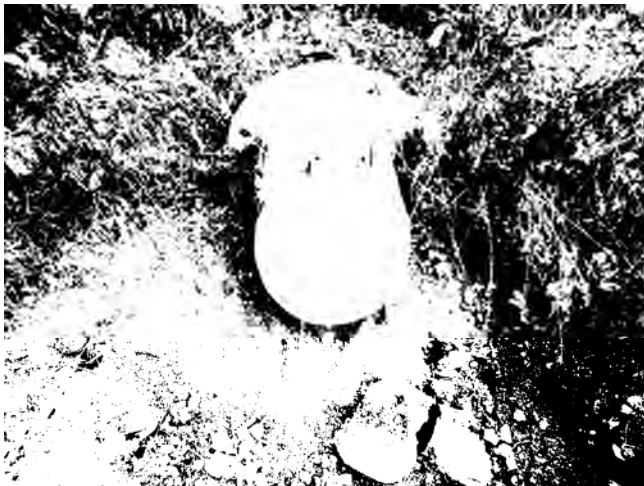
Overflow outlet closed

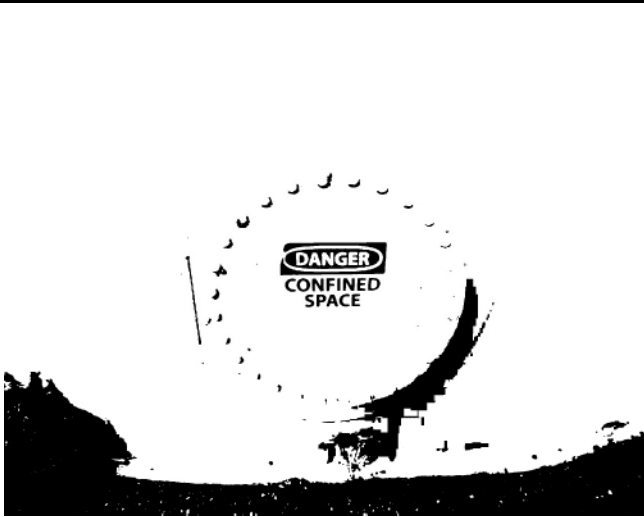
Summary: The manways were found secure and in good condition with moderate sags & runs in the coating and chalking noted.

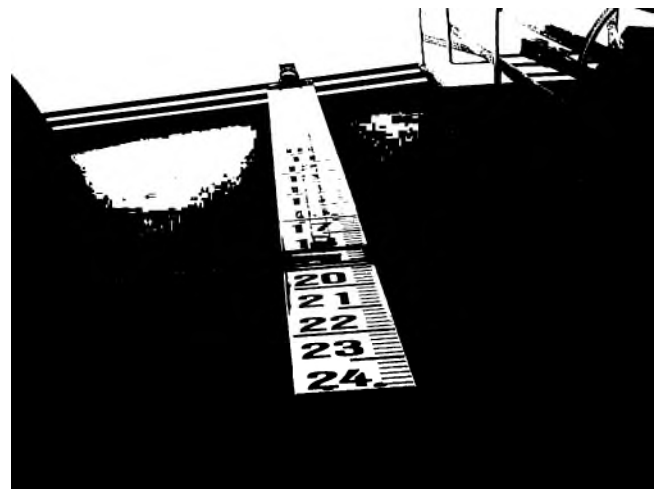
Summary: The water level indicator was found in good condition with fading noted at the top of the board.

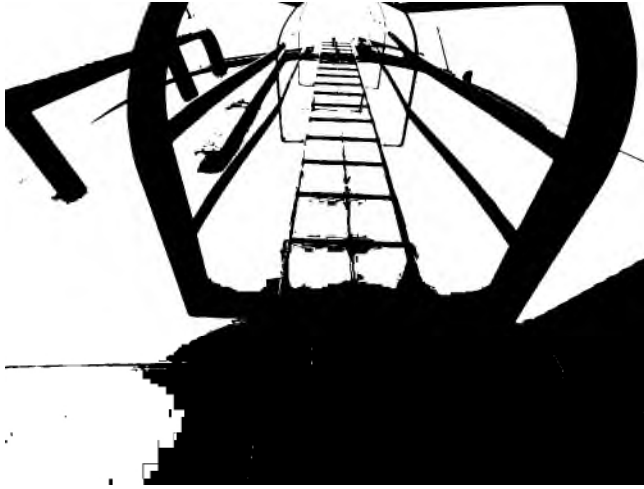
Summary: The ladder was found secure, OSHA approved and in good condition with minor sags & runs in the coating and chalking noted.

Ladder overall

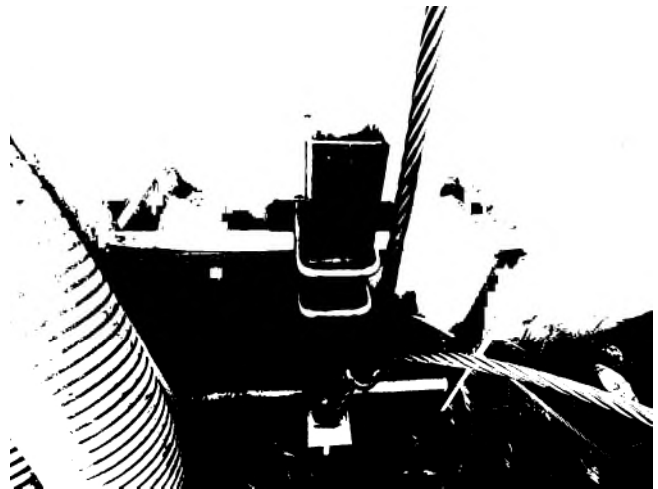
Ladder cable
